## Post Installation Report

**Project:** Greenway Hall Golf Club

**Application:** Driving Range Floodlighting System

**Scheme reference:** UKS15730\_2

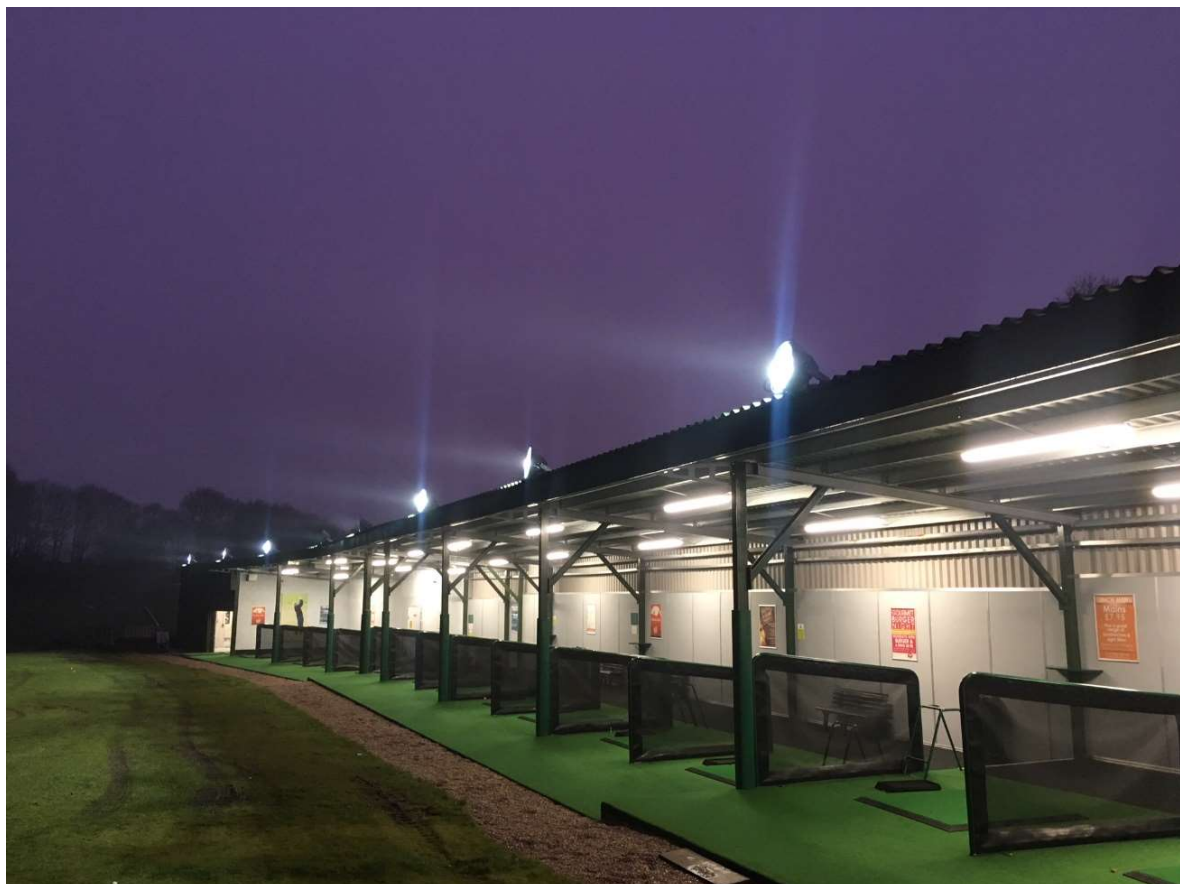
**Comments:** The floodlights appear to have been installed in compliance with the lighting scheme (ref UKS1573\_2), and in line with the planning requirements. Figure 1 shows all the floodlights installed in the correct positions and with the correct elevations. Light readings were taken at the boundary of each of the residential properties on the road running along the length of the range, with a maximum reading of 2.9 lux being taken. It should be noted that these were taken on the boundary as access could not be given onto the properties so readings could be taken directly at each house, if this was done then the readings would be slightly lower. Following discussions with one of the clubs employees no complaints have been received from any of the residents, which is understandable as no lights are pointing in the direct vicinity of each property. Please see the below photos taken during the visit, more photos were taken and are available upon request.

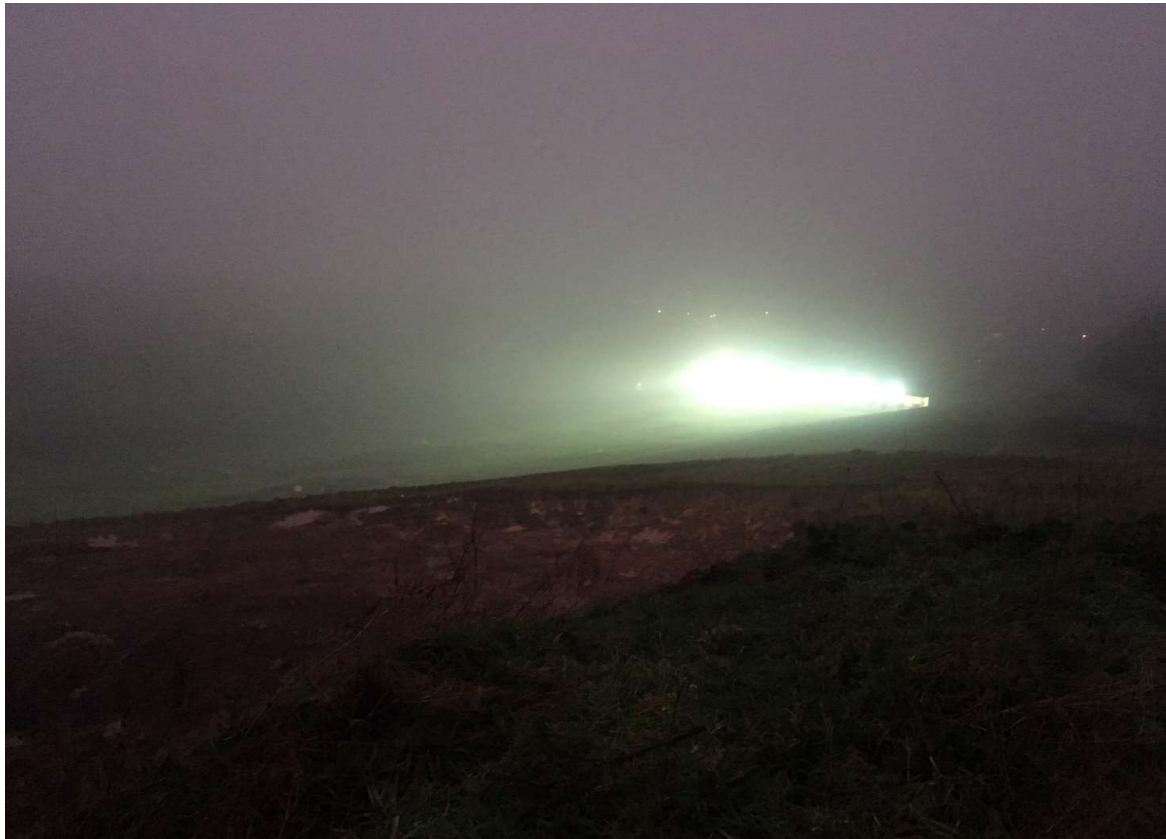
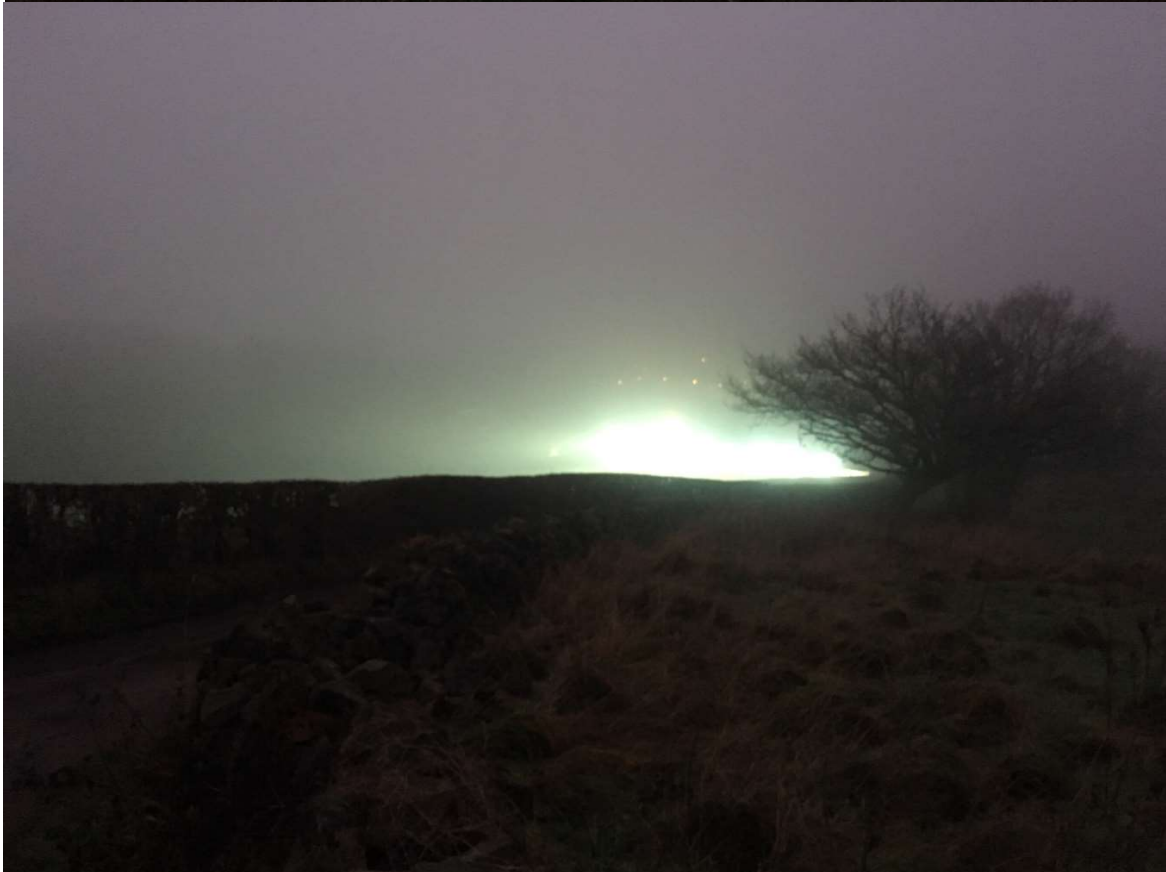
**Conclusion:** In my opinion the floodlighting installation is as per the requirements of the lighting scheme, and subsequently the planning requirements. The lighting isn't causing any disruption or nuisance to the surrounding residential properties. The performance of the lighting out into the range appears visually very good.
