Project: Standard Details

Title: ANPR Lighting Column (4m)  
General Arrangement

Drg. No: C-0000-001.1 Rev: A

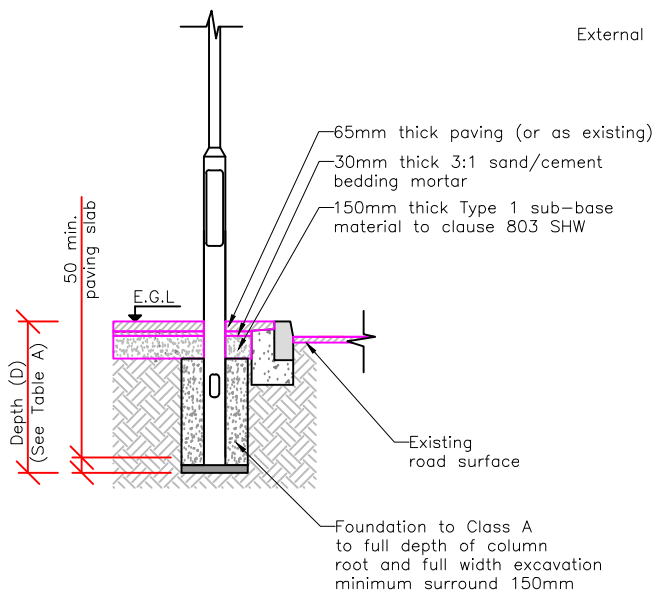
Column Foundation and  
Reinstatement Details

| TABLE A: | DEPTH (D) (mm) | | |
| COLUMN HEIGHT (H) (mm) | G630 GOOD SOIL | G390 AVERAGE SOIL | G230 POOR SOIL |
| 5000 | 800 | 1000 | 1200 |

Soil Type: (Factor G) (BS 5649 Part 2)
