**PROPOSED REMEDIAL REPAIR WORKS/MAKING-GOOD
TO THE SOUTHWEST (REAR) ELEVATION OF
THE SWISS COTTAGE (c.1840, Grade II Listed)**

ALTON TOWERS RESORT | ALTON | STAFFORDSHIRE

Conservation Design and Access Statement
incorporating a Heritage Statement

November 2021

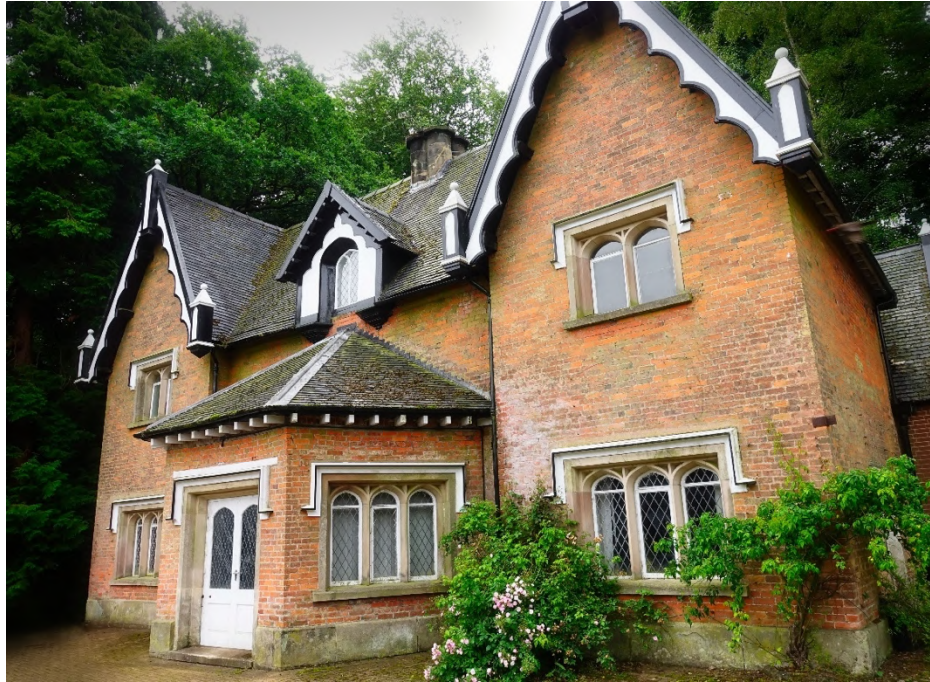
Fig.2 The orange brick symmetrical composition of the north front elevation of The Swiss Cottage (Source: Alton Towers)

Built in a Tudor-Gothic style, for the 16th Earl of Shrewsbury, The Swiss Cottage is of constructed of orange brick with a local Hollington sandstone plinth and arched-head stone window and door frames. The steeply-pitched Staffordshire Blue plain clay tiled roof has a central sandstone octagonal chimney stack, with decorative cusped timber gable barge boards and eaves finial details. The 2-storey building has a symmetrical composition with a projecting front porch and entrance doorway (fig.2).

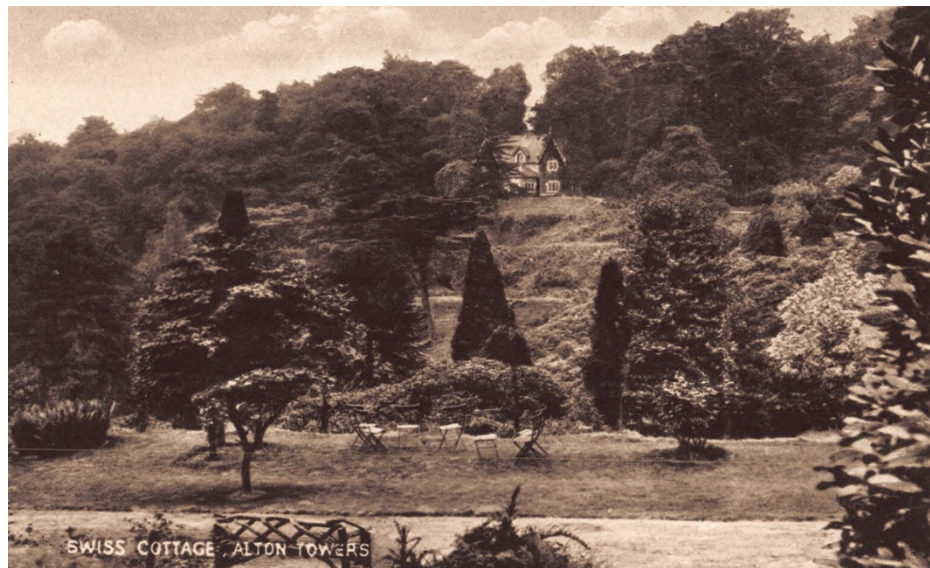
Fig.3 Postcard image of The Swiss Cottage looking southwards across the valley, circa 1900 (Source: Alton Towers Archive)

The Swiss Cottage was designed primarily as a focal point in the gardens to be viewed from the north side terraces and to resemble an alpine lodge on the valley slopes. This intended view remains today as can be seen in the 1900's photo (fig.3).

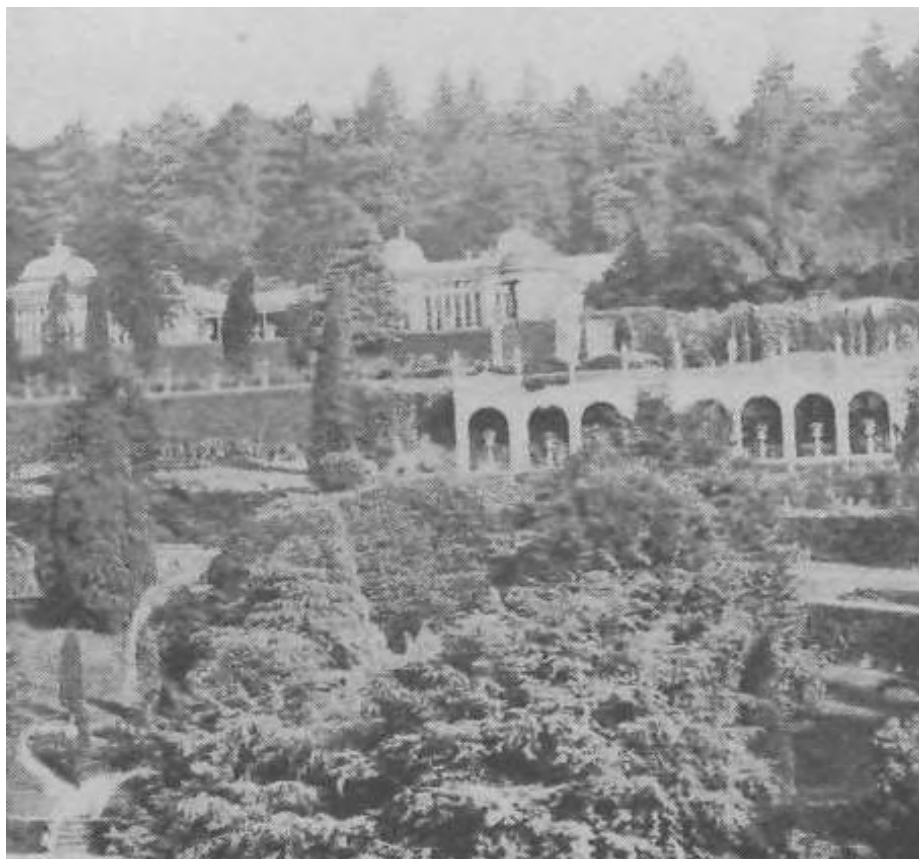
Fig.4 The view of the gardens from The Swiss Cottage looking northwards across the valley to the Loggia and Grand 'Garden' Conservatory, *circa* 1871. This view is now largely masked by mature trees (*Source: Alton Towers Archive*)

the gardens and in particular the Grand 'Garden' Conservatory, the Quarry Greenhouse 'Orangery', the 'Dutch Garden', Stonehenge, The Loggia, the 'Gothic' Prospect Tower and the 'Chinese' Pagoda Fountain, within this view (*fig.4*).

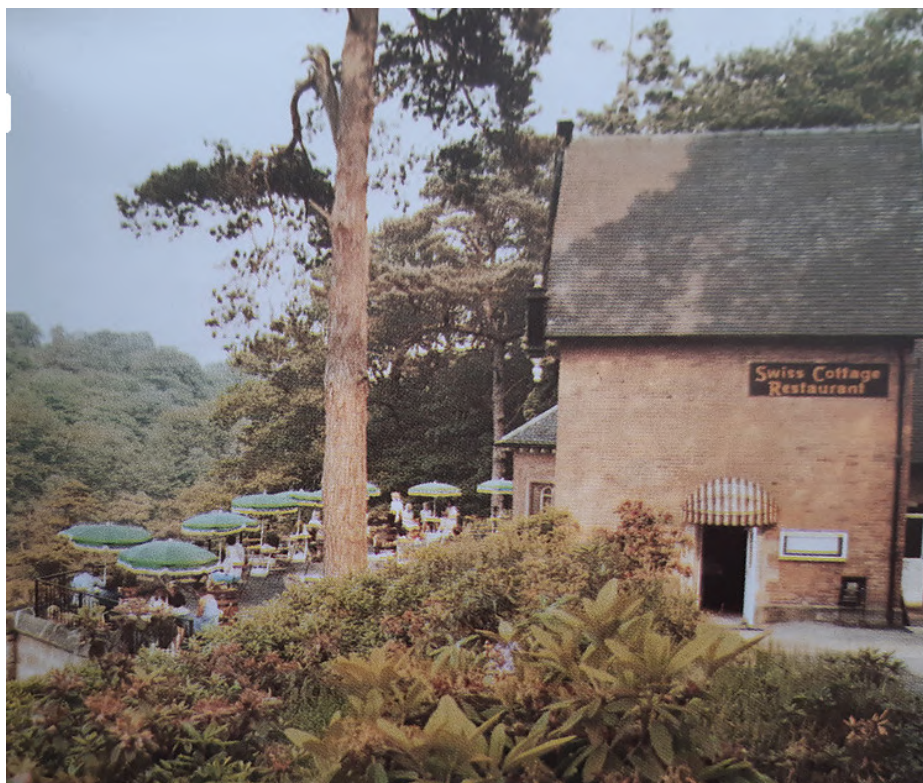
Fig.5 The Swiss Cottage Restaurant looking from the west with the popular terrace dining area in the late 1970's. Note the red and white striped canopy over the original single side door entrance before the construction of the southwest infill extension (Source: Alton Towers Archive)

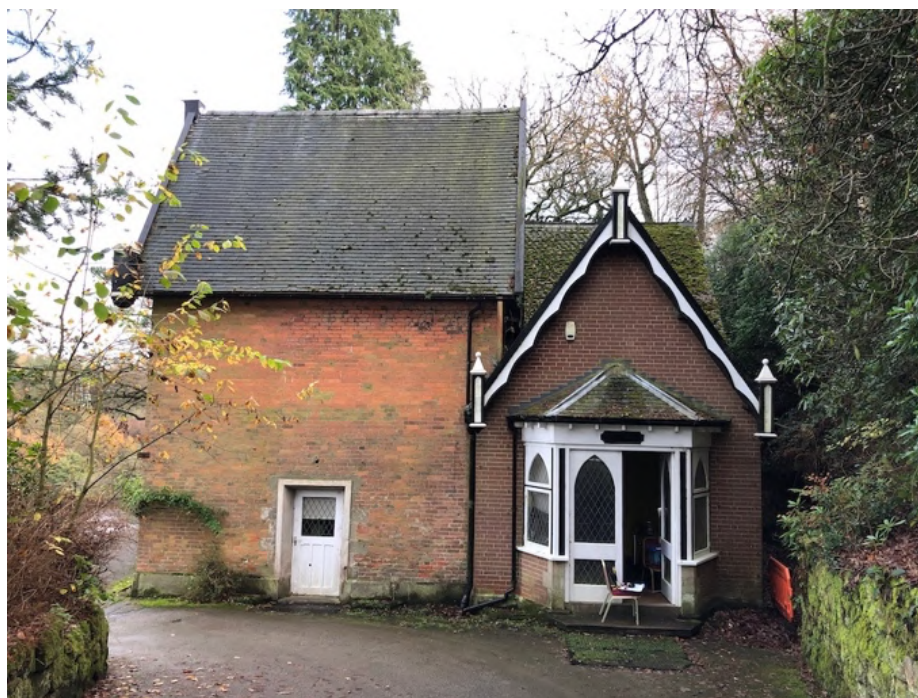
Fig.6 The west elevation today with the 1980's southwest infill extension and new side entrance lobby (Source: ctd architects, 2020)

In the 1980's an extension was added to the southwest corner to create a more suitable entrance lobby (*fig.6*) and a large flat-roofed, commercial kitchen was also added to the southwest (rear) elevation, built up against the rock-faced embankment, so it could function as a restaurant.

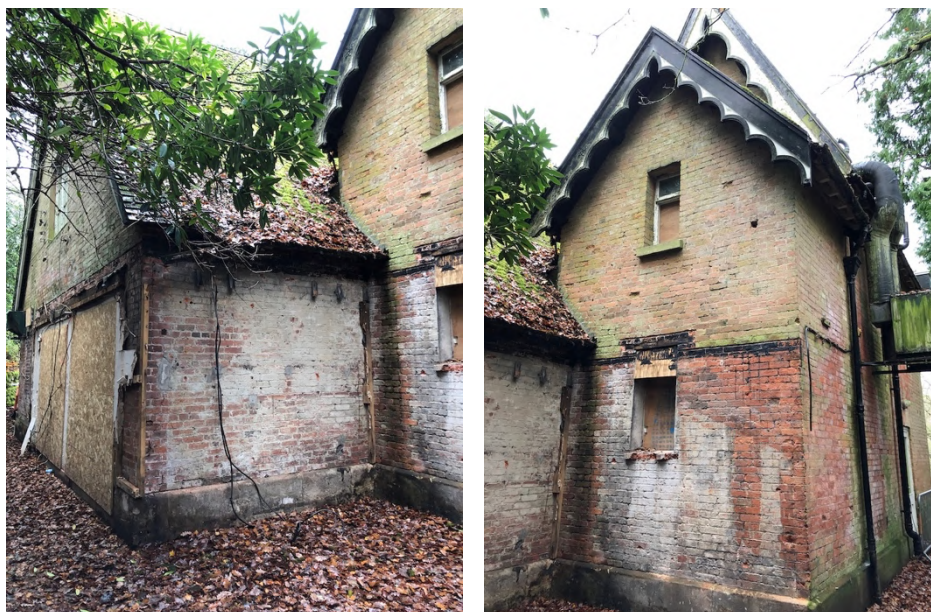
Fig.7 The south (rear) elevation looking from the southeast, following the removal of the modern flat-roofed kitchen extension in 2019. These are the elevations to be repaired and restored (Source: ctd architects, 2020)

In 2019, following the collapse of the modern felted flat roof to the rear kitchen extension, a decision was taken in conjunction with the local planning authority's conservation officer to remove the rear extension completely and to repair and restore the original rear elevation. The repair proposals are set out in this application for Listed Building Consent.

In order to prevent damage to the exposed rear of the cottage, the openings have been temporarily boarded for security and weather protection ahead of the proposed repair works.

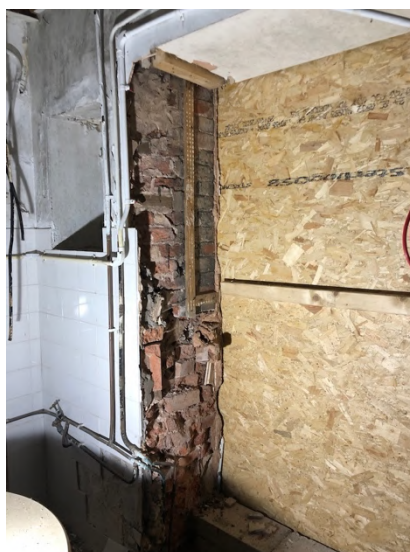
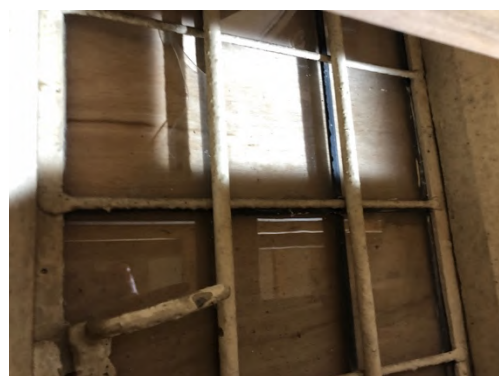
Figs.8 & 9 (left) Splayed and cut brickwork reveals to enlarged former window opening W.0.3; and (right) original metal-framed leaded light casement window W.0.2 currently boarded-over. Archaeological evidence informing the repair and reinstatement proposals (Source: ctd architects, 2021)

The principal works to the south (rear) elevation of The Swiss Cottage involve the reinstatement of the former doorway with a new vertical boarded painted timber door and frame, and the reinstatement of a former window opening by rebuilding the elevation back up to cill height (as evidenced by the cut-bricks and splayed brick reveals – *fig.8*) using salvaged bricks bedded in a lime : sand mortar, and the installation of a new 12-light painted timber, opening casement window. Internally the window reveals and new brickwork to cill height will be finished with a lime plaster.
