## Heritage Statement

**Project Title:** Barn/Stable, formerly Cottage North east of Smithy  
Farley  
Staffordshire  
ST10 3BQ

**Client:** Daylesford

Barn/Stable, formerly Barn to north east of Smithy, Farley, Staffordshire ST10 3BQ

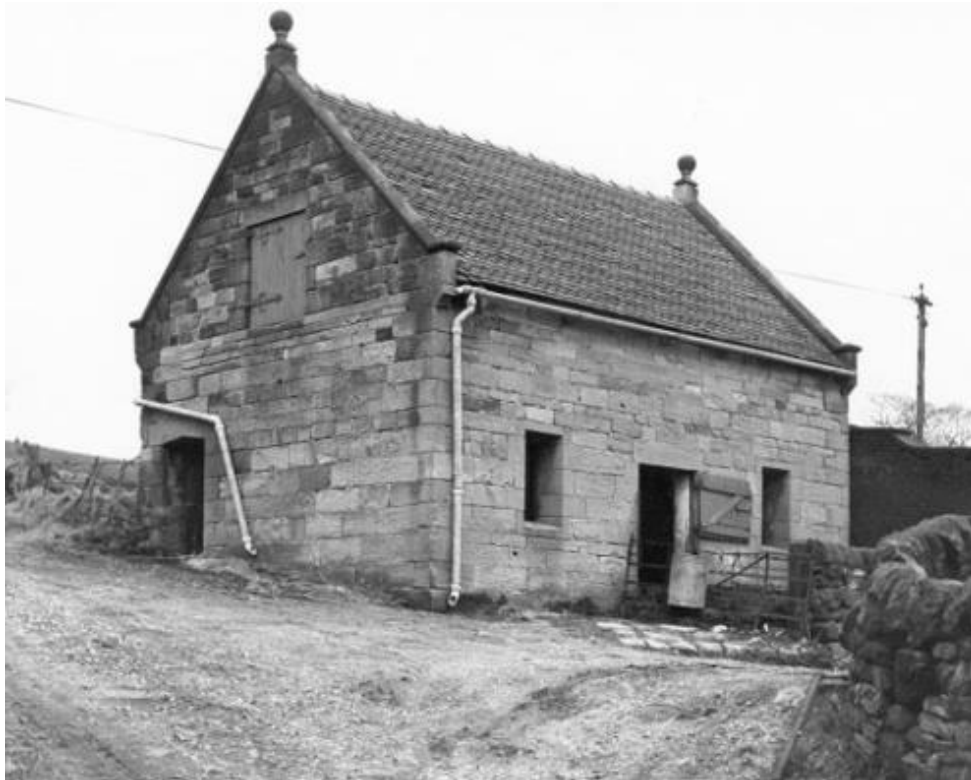
**Stable/barn in 1962. Photo credit: Staffordshire Pasttrack**

| 0.0 | <b>Background and History</b> |
|---|---|
| | <p>The Barn, formerly Stable, is a Grade II listed building in Farley, Staffordshire, built in the mid 19<sup>th</sup> Century, as dated 1851 by the roof tile. It is freestanding, and of ashlar herringbone tooling, with a plain tile roof.</p> <p>Please see the listing below from Historic England for a more detailed description.</p> <p><b>Historic England Listing:</b></p> <p>Heritage Category: Listed Building</p> <p>Grade: II</p> <p>List Entry Number: 1192162</p> <p>Date first listed: 03-Jan-1967</p> <p>Date of most recent amendment: 17-Nov-1986</p> <p><b>Statutory Address: STABLE APPROXIMATELY 25 YARDS NORTH EAST OF THE SMITHY</b></p> <p>The building or site itself may lie within the boundary of more than one authority.</p> <p>County: Staffordshire</p> <p>District: Staffordshire Moorlands (District Authority)</p> <p>Parish: Farley</p> |

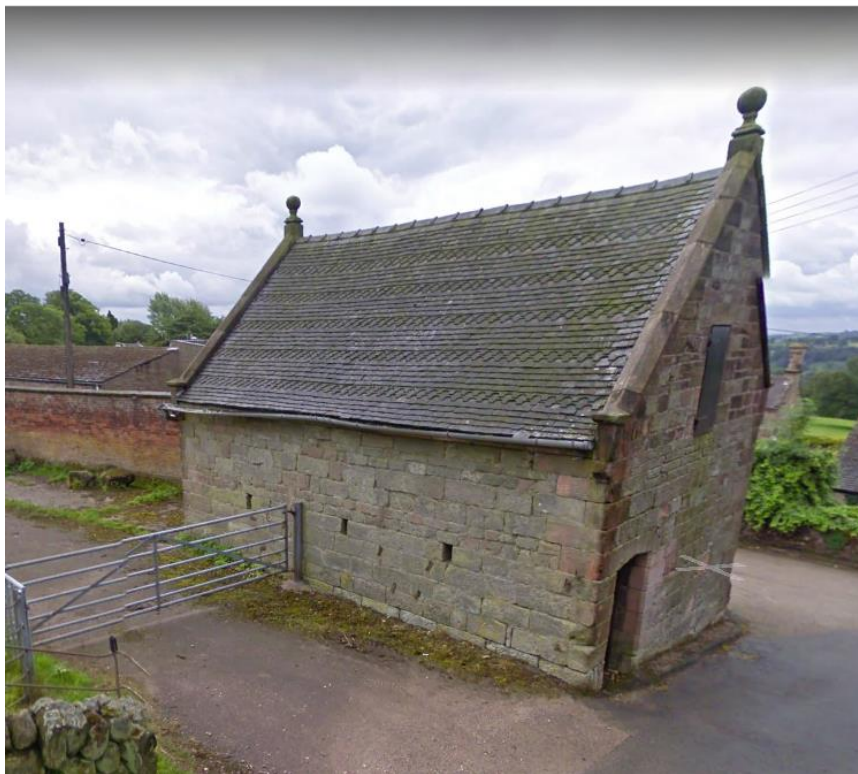
**Barn 2021**

| | <p>Any interior work will avoid the removal of features such as staircases, panelling, mouldings or internal spaces.</p> <p>Then historic development of the building should remain evident.</p> <p>With reference to the above, the barn is currently empty and in need of restoration work.</p> |
