THE BARN

EXISTING GROUND FLOOR PLAN  
1690.04\_110\_01

STATUS: Issued for Tender  
DATE: October 2021  
SCALE: 1:50 @ A1

CLIENT: daylesford  
ORGANIC FARM GLOUCESTERSHIRE

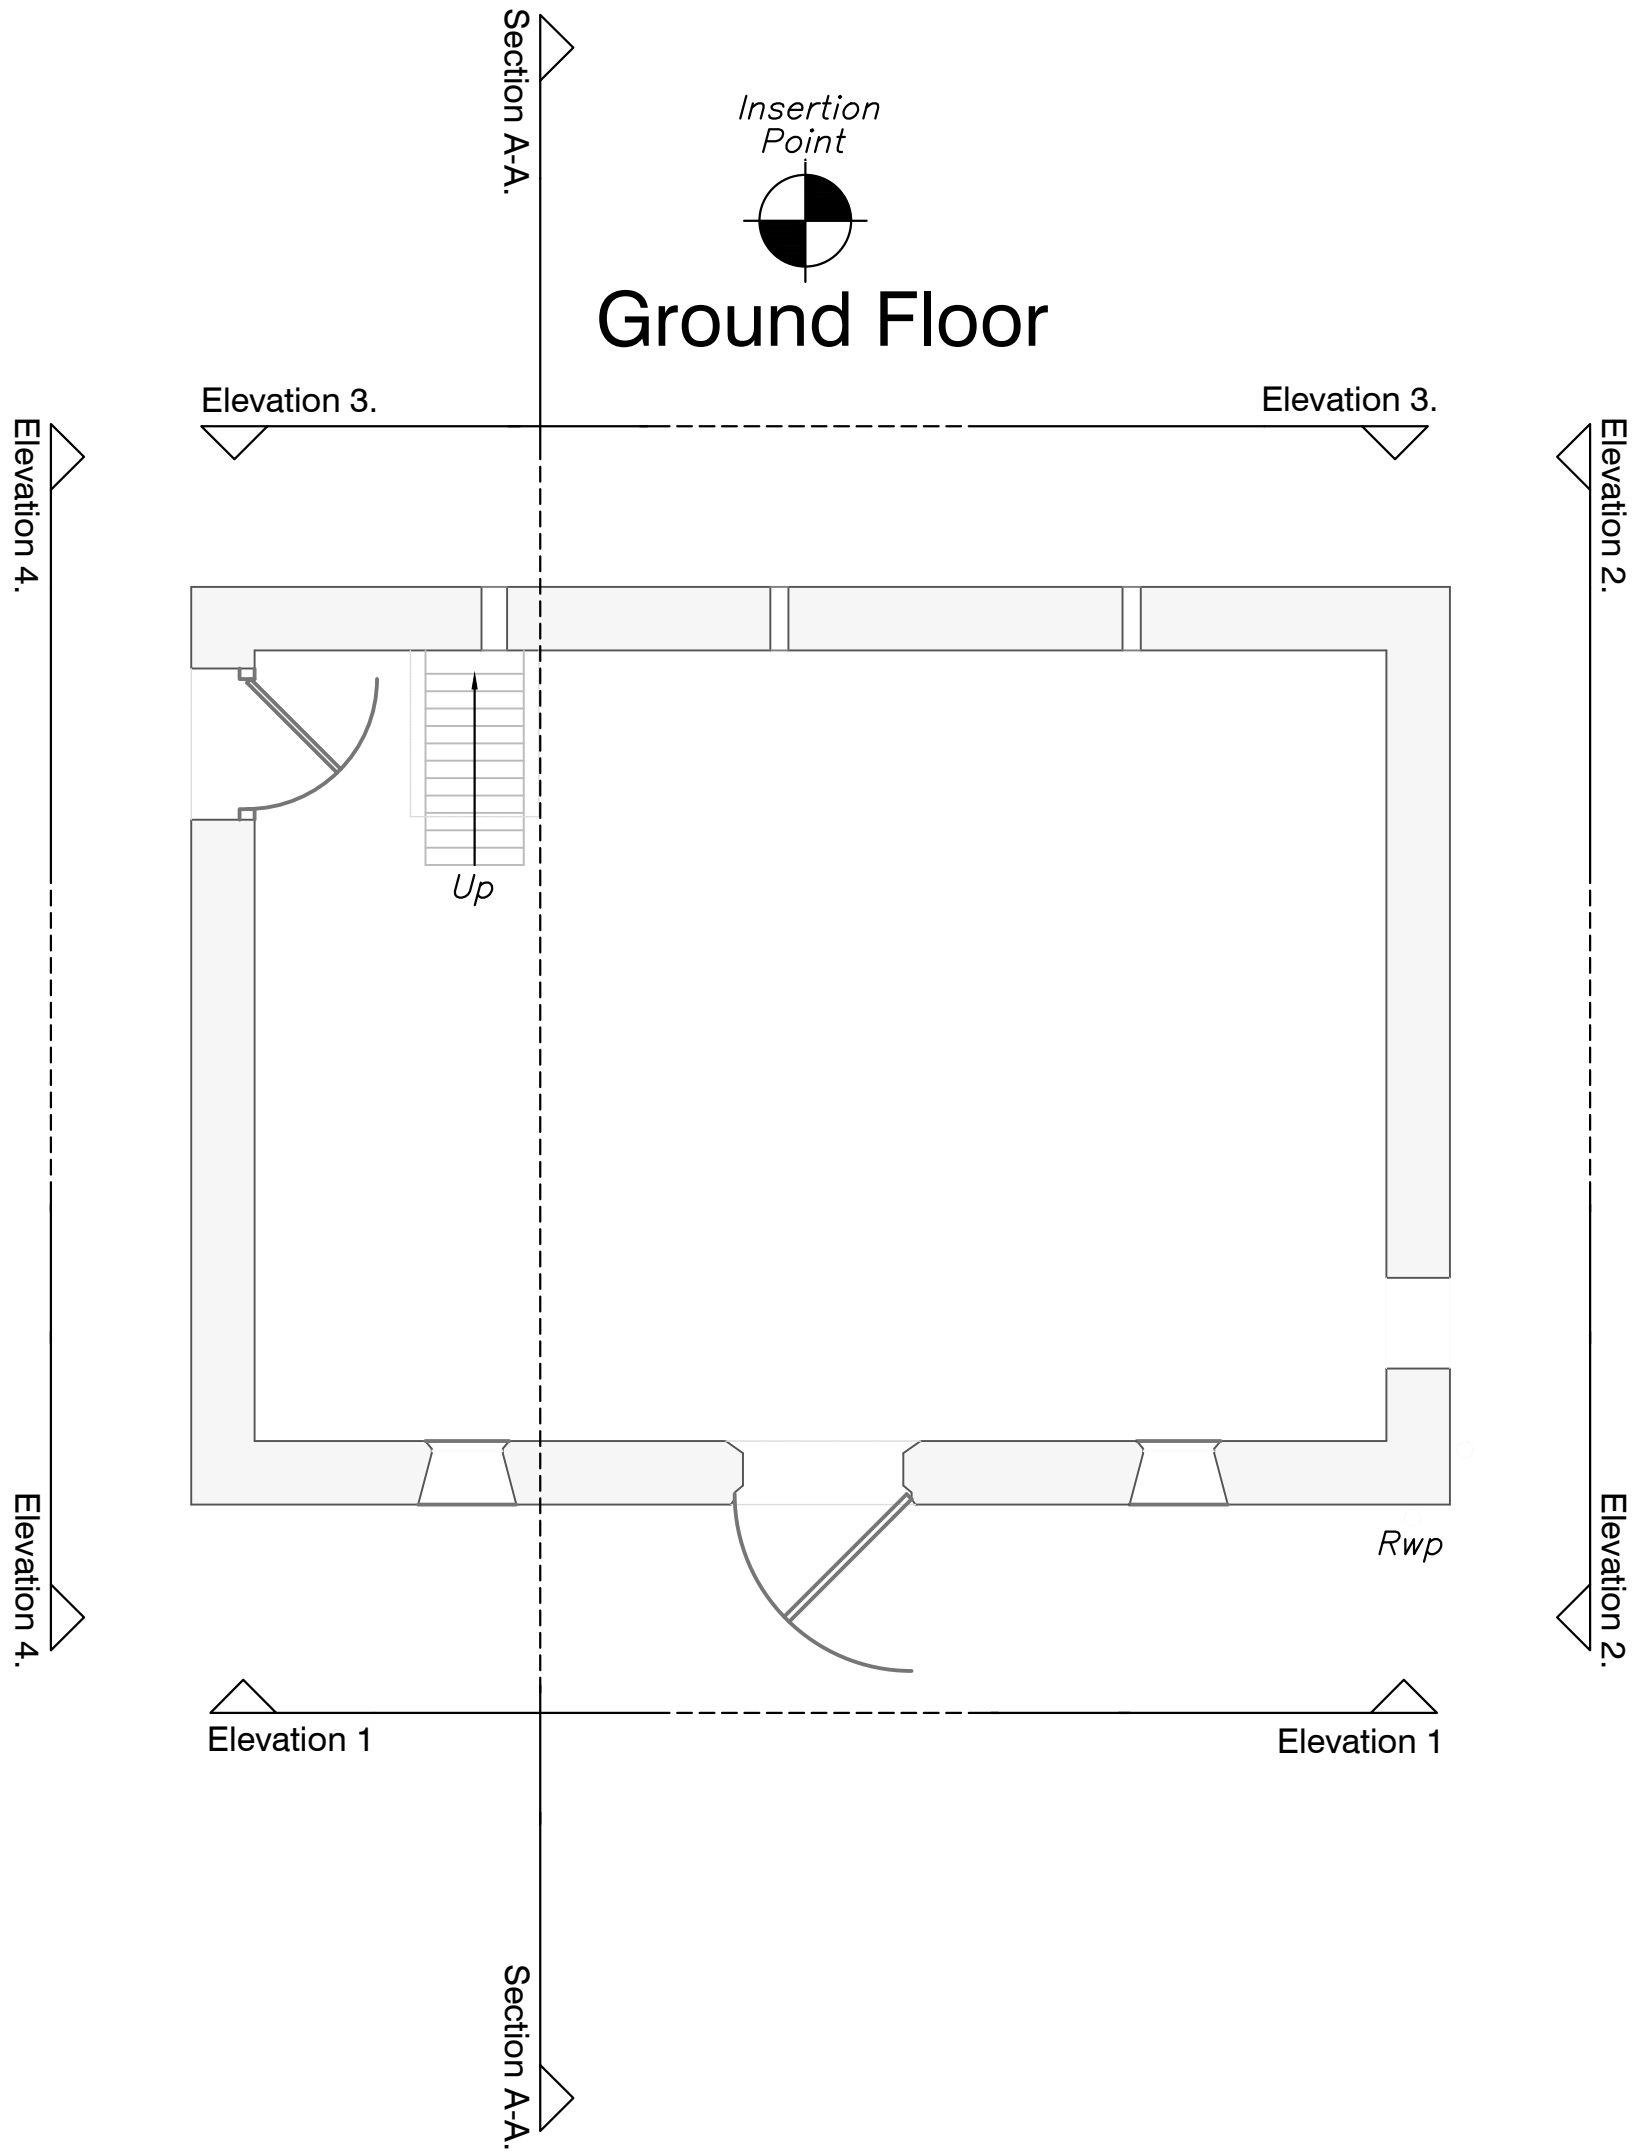
01  
Existing Ground Floor Plan 1:50

- NOTES
- 07 Structural opening to be formed
  - External works
  - 10 Existing doors and windows to be painted in Daylesford Green- Facia & Eaves boards
  - 11 Existing gutters and RWP in poor condition to be replaced
  - 12 Proposed timber window
  - Proposed demolition works
