THE BARN

EXISTING FIRST FLOOR PLAN  
1690.04\_110\_02

STATUS: Issued for Tender  
DATE: October 2021  
SCALE: 1:50 @ A1

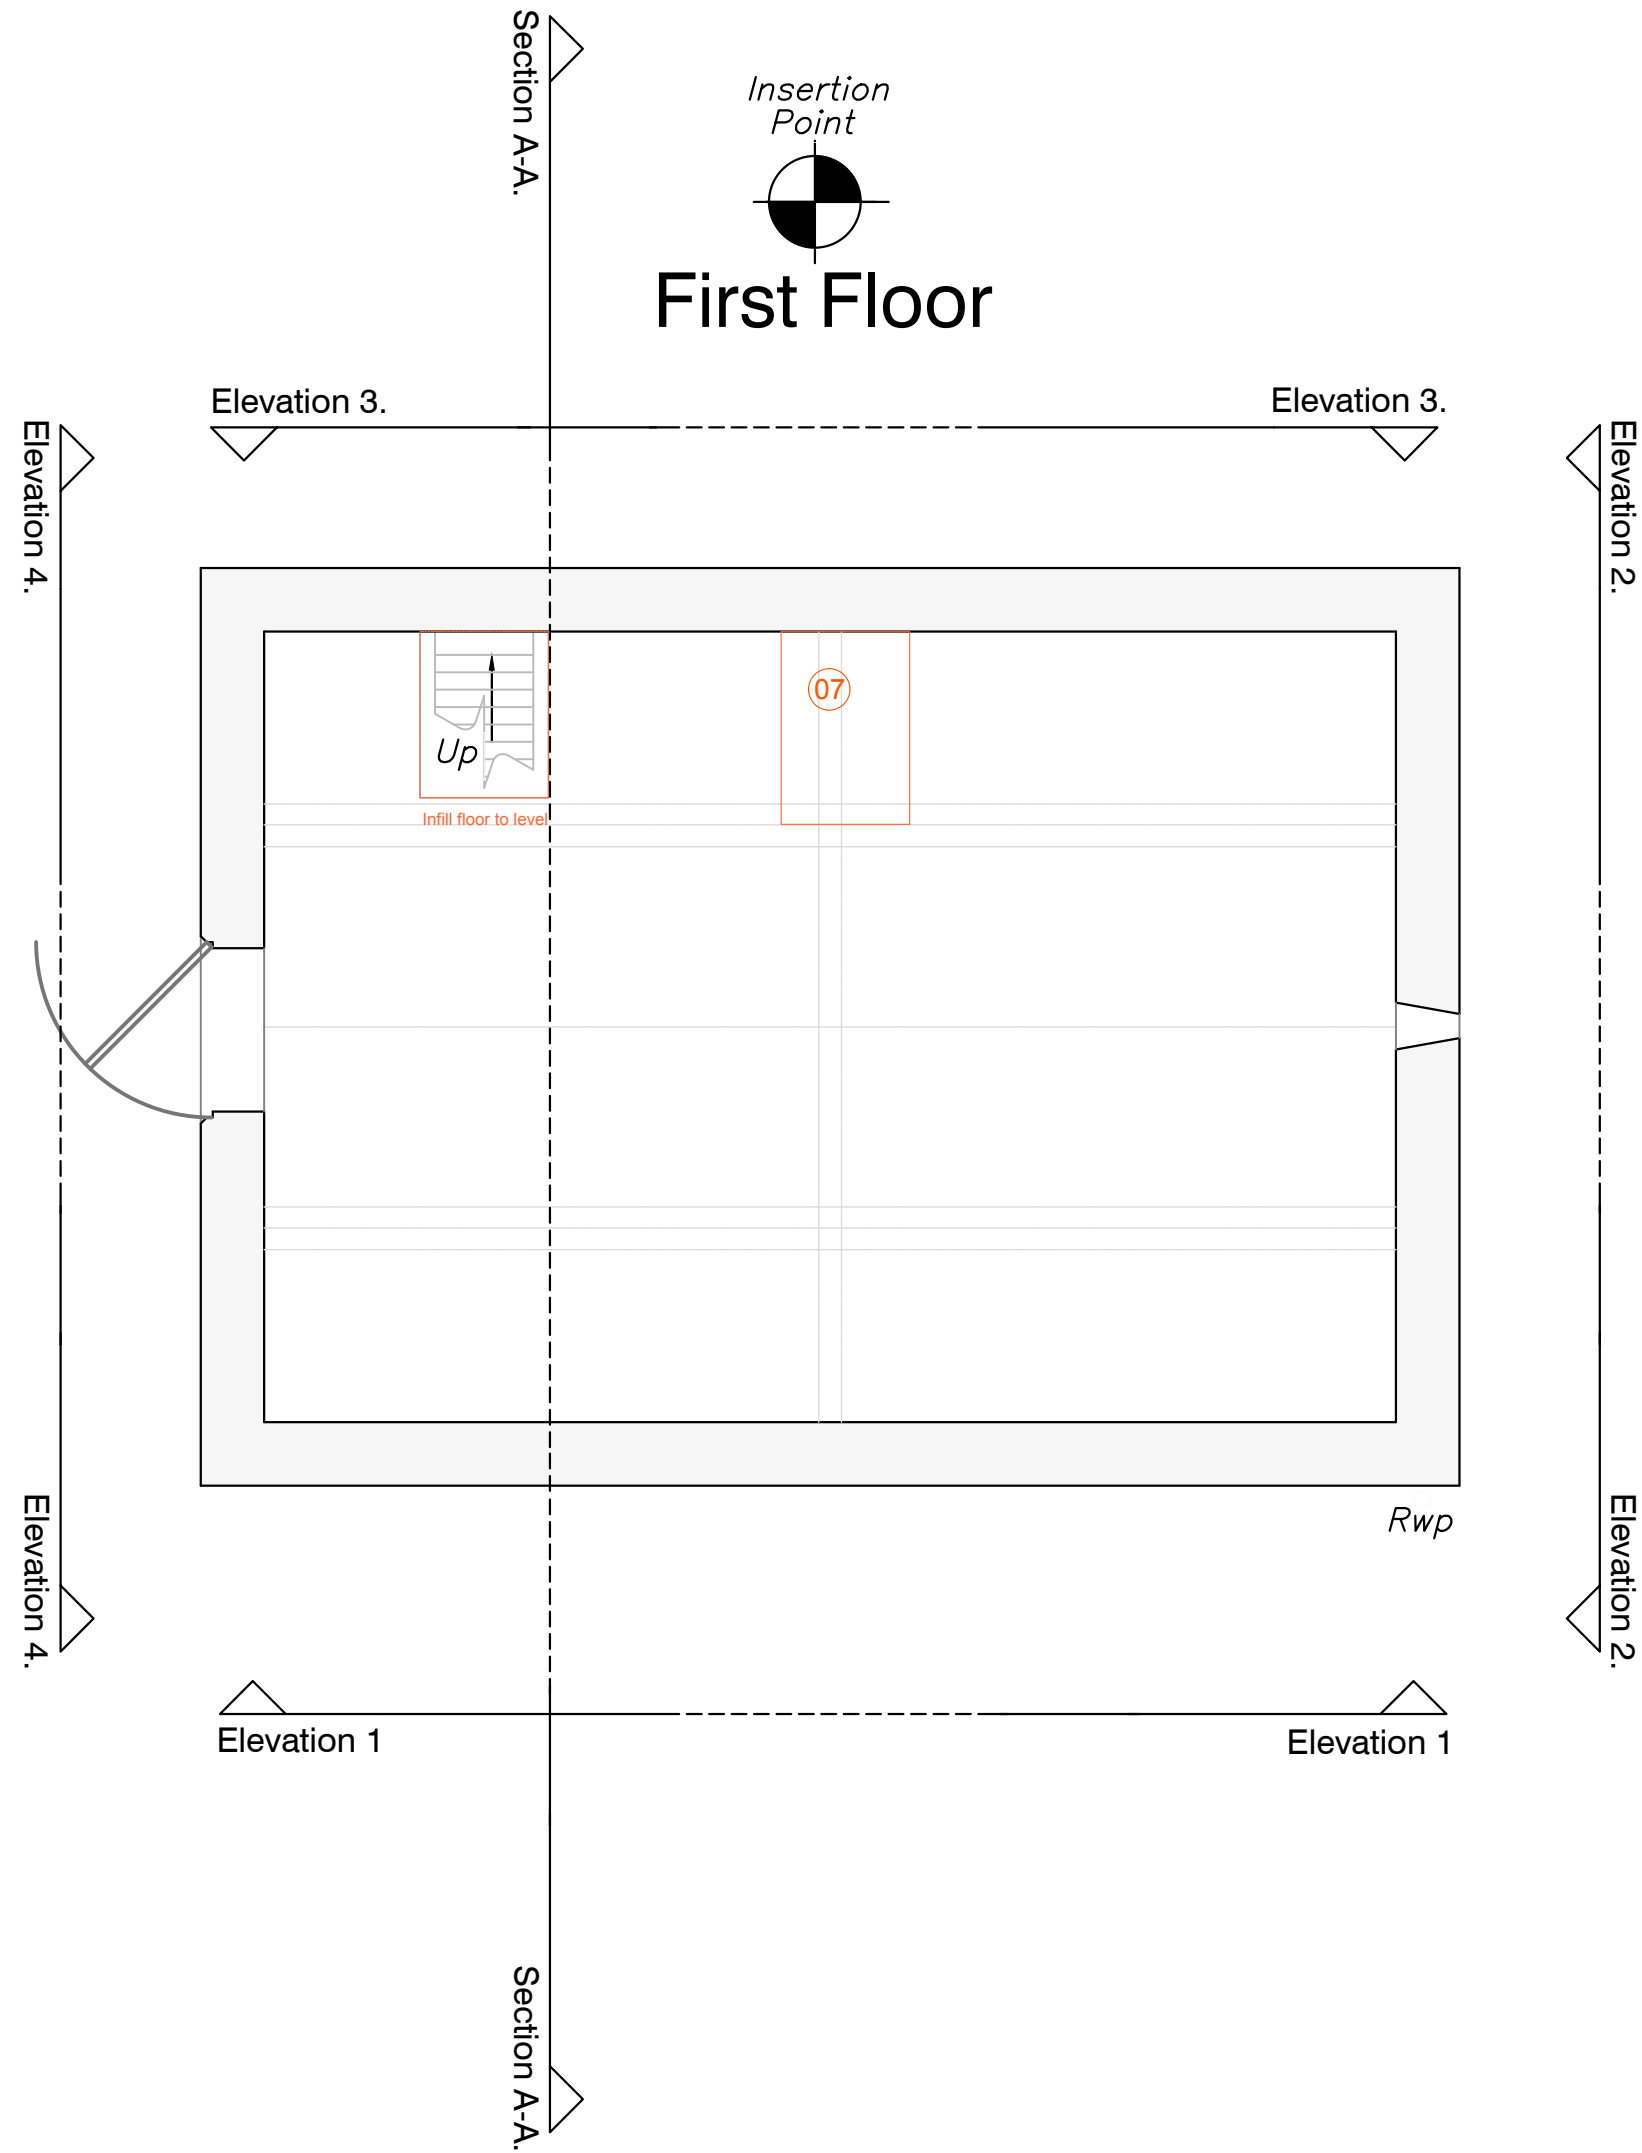
02  
Existing First Floor Plan 1:50

- NOTES
- 07 Structural opening to be formed
- External works
- 10 Existing doors and windows to be painted in Daylesford Green- Facia & Eaves boards
  - 11 Existing gutters and RWP in poor condition to be replaced
  - 12 Proposed timber window
- Proposed demolition works
