THE BARN

EXISTING ROOF PLAN

1690.04\_110\_03

STATUS: Issued for Tender

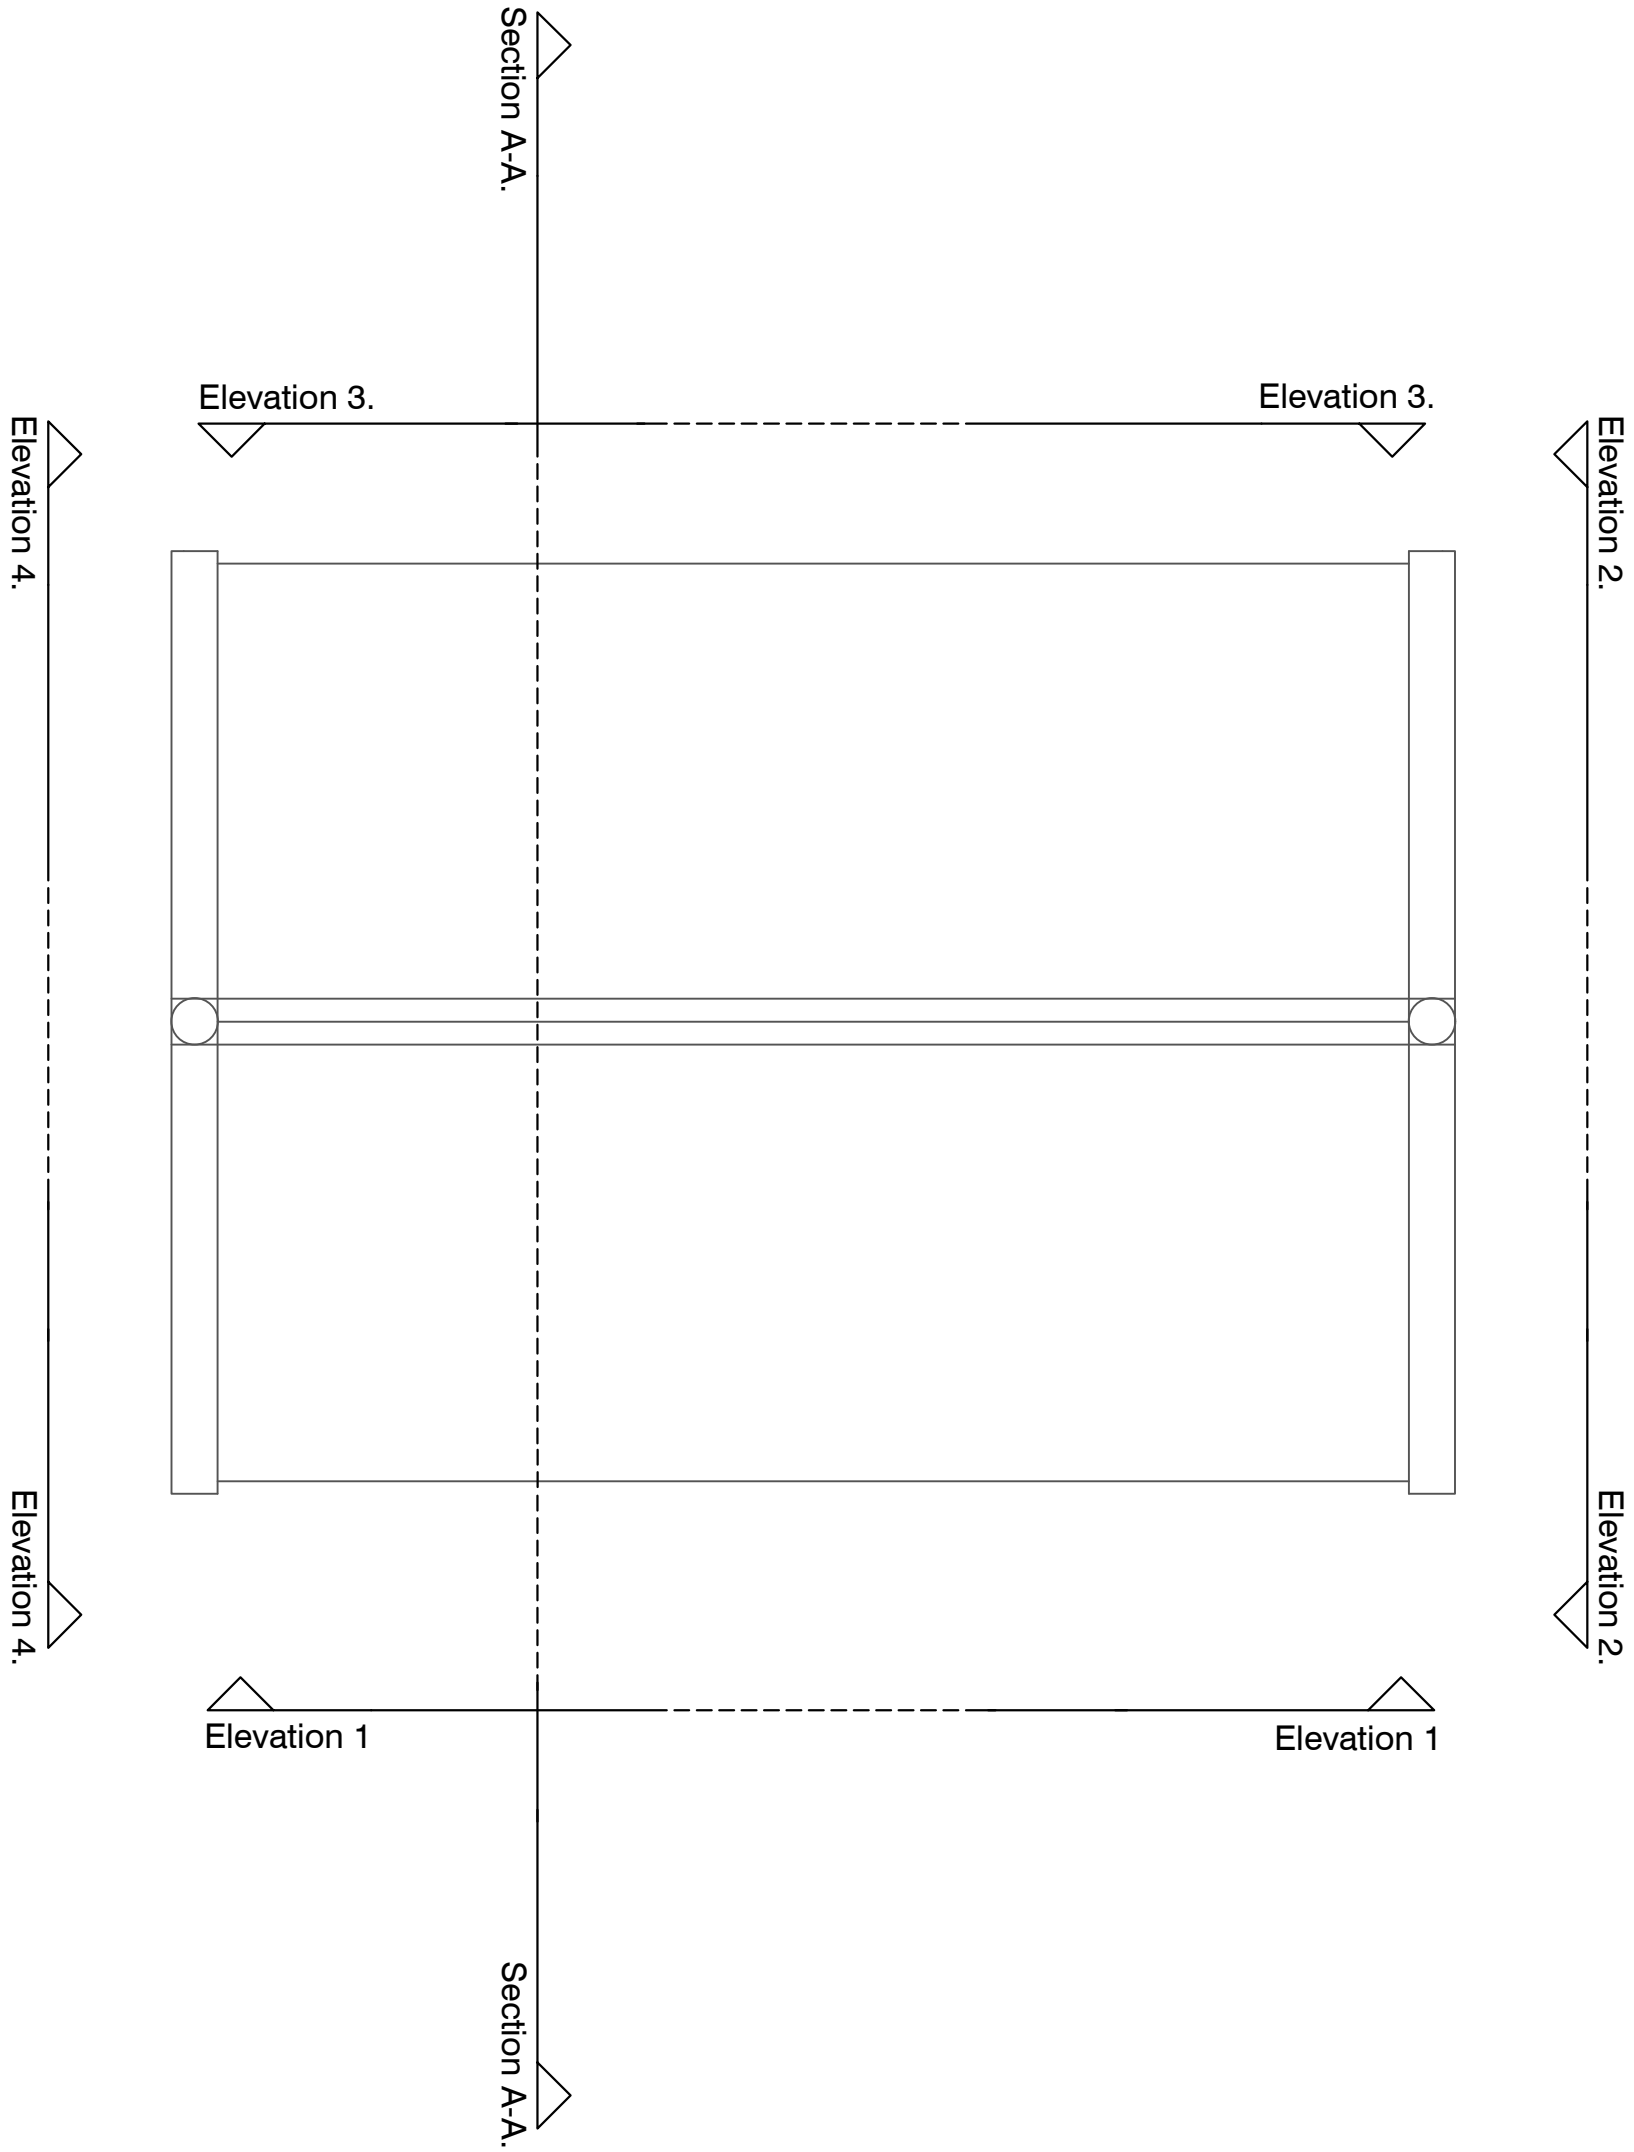
Existing Roof Plan

Structural opening to be formed
- External works
- 10

Existing doors and windows to be painted in Daylesford Green- Facia & Eaves boards
- 11

Existing gutters and RWP in poor condition to be replaced
- 12

Proposed timber window
- Proposed demolition works
