THE BARN

EXISTING SECTION  
1690.04\_120\_03

CLIENT:  
daylesford  
ORGANIC FARM GLOUCESTERSHIRE

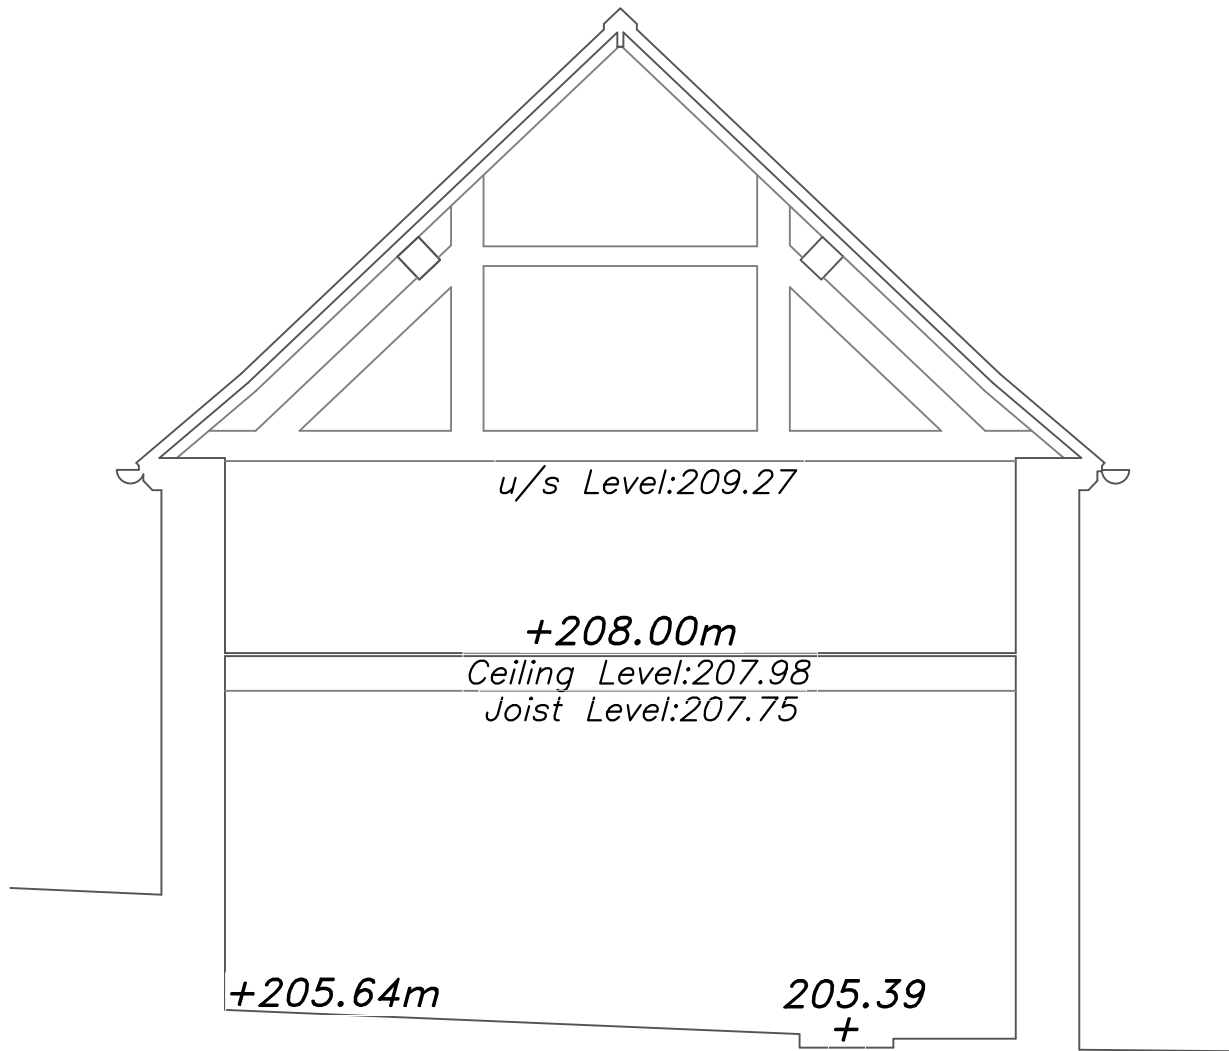
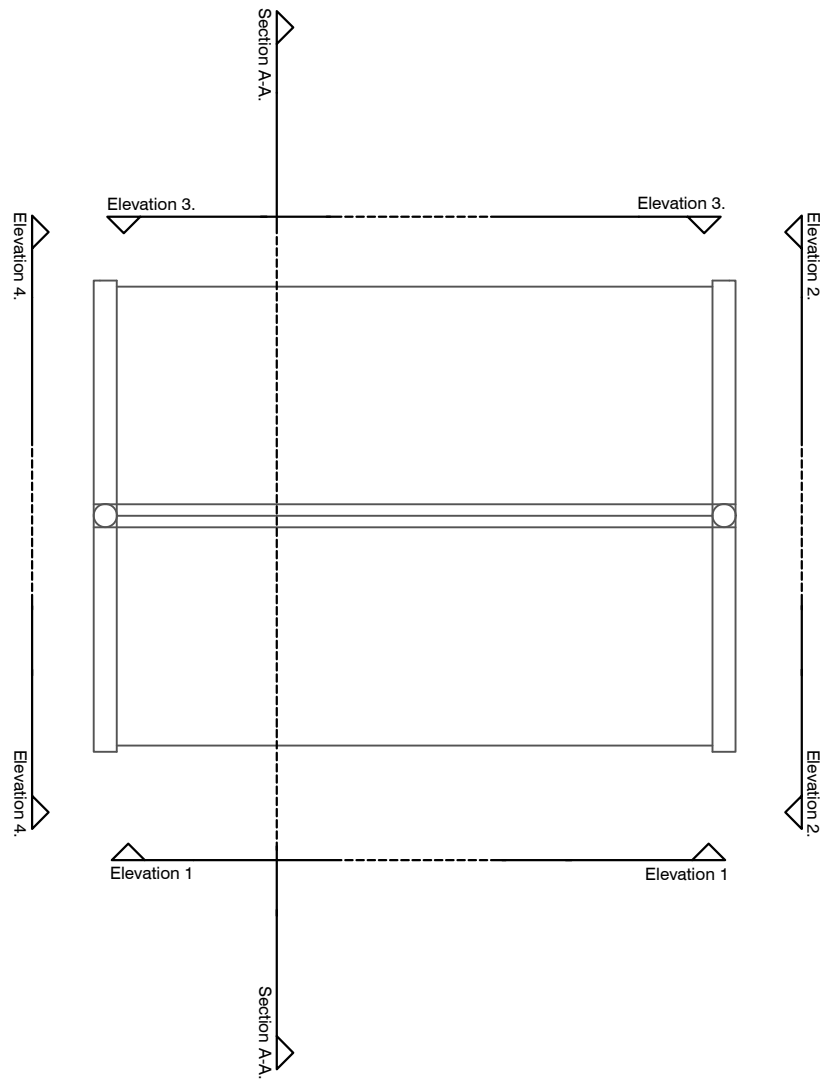
03  
Existing Section 1:50

- NOTES
- 07 Structural opening to be formed
  - External works
  - 10 Existing doors and windows to be painted in Daylesford Green- Facia & Eaves boards
  - 11 Existing gutters and RWP in poor condition to be replaced
  - 12 Proposed timber window
  - Proposed demolition works

Datum: 200.00m.  
Section A-A.
