Existing Ground Floor Plan

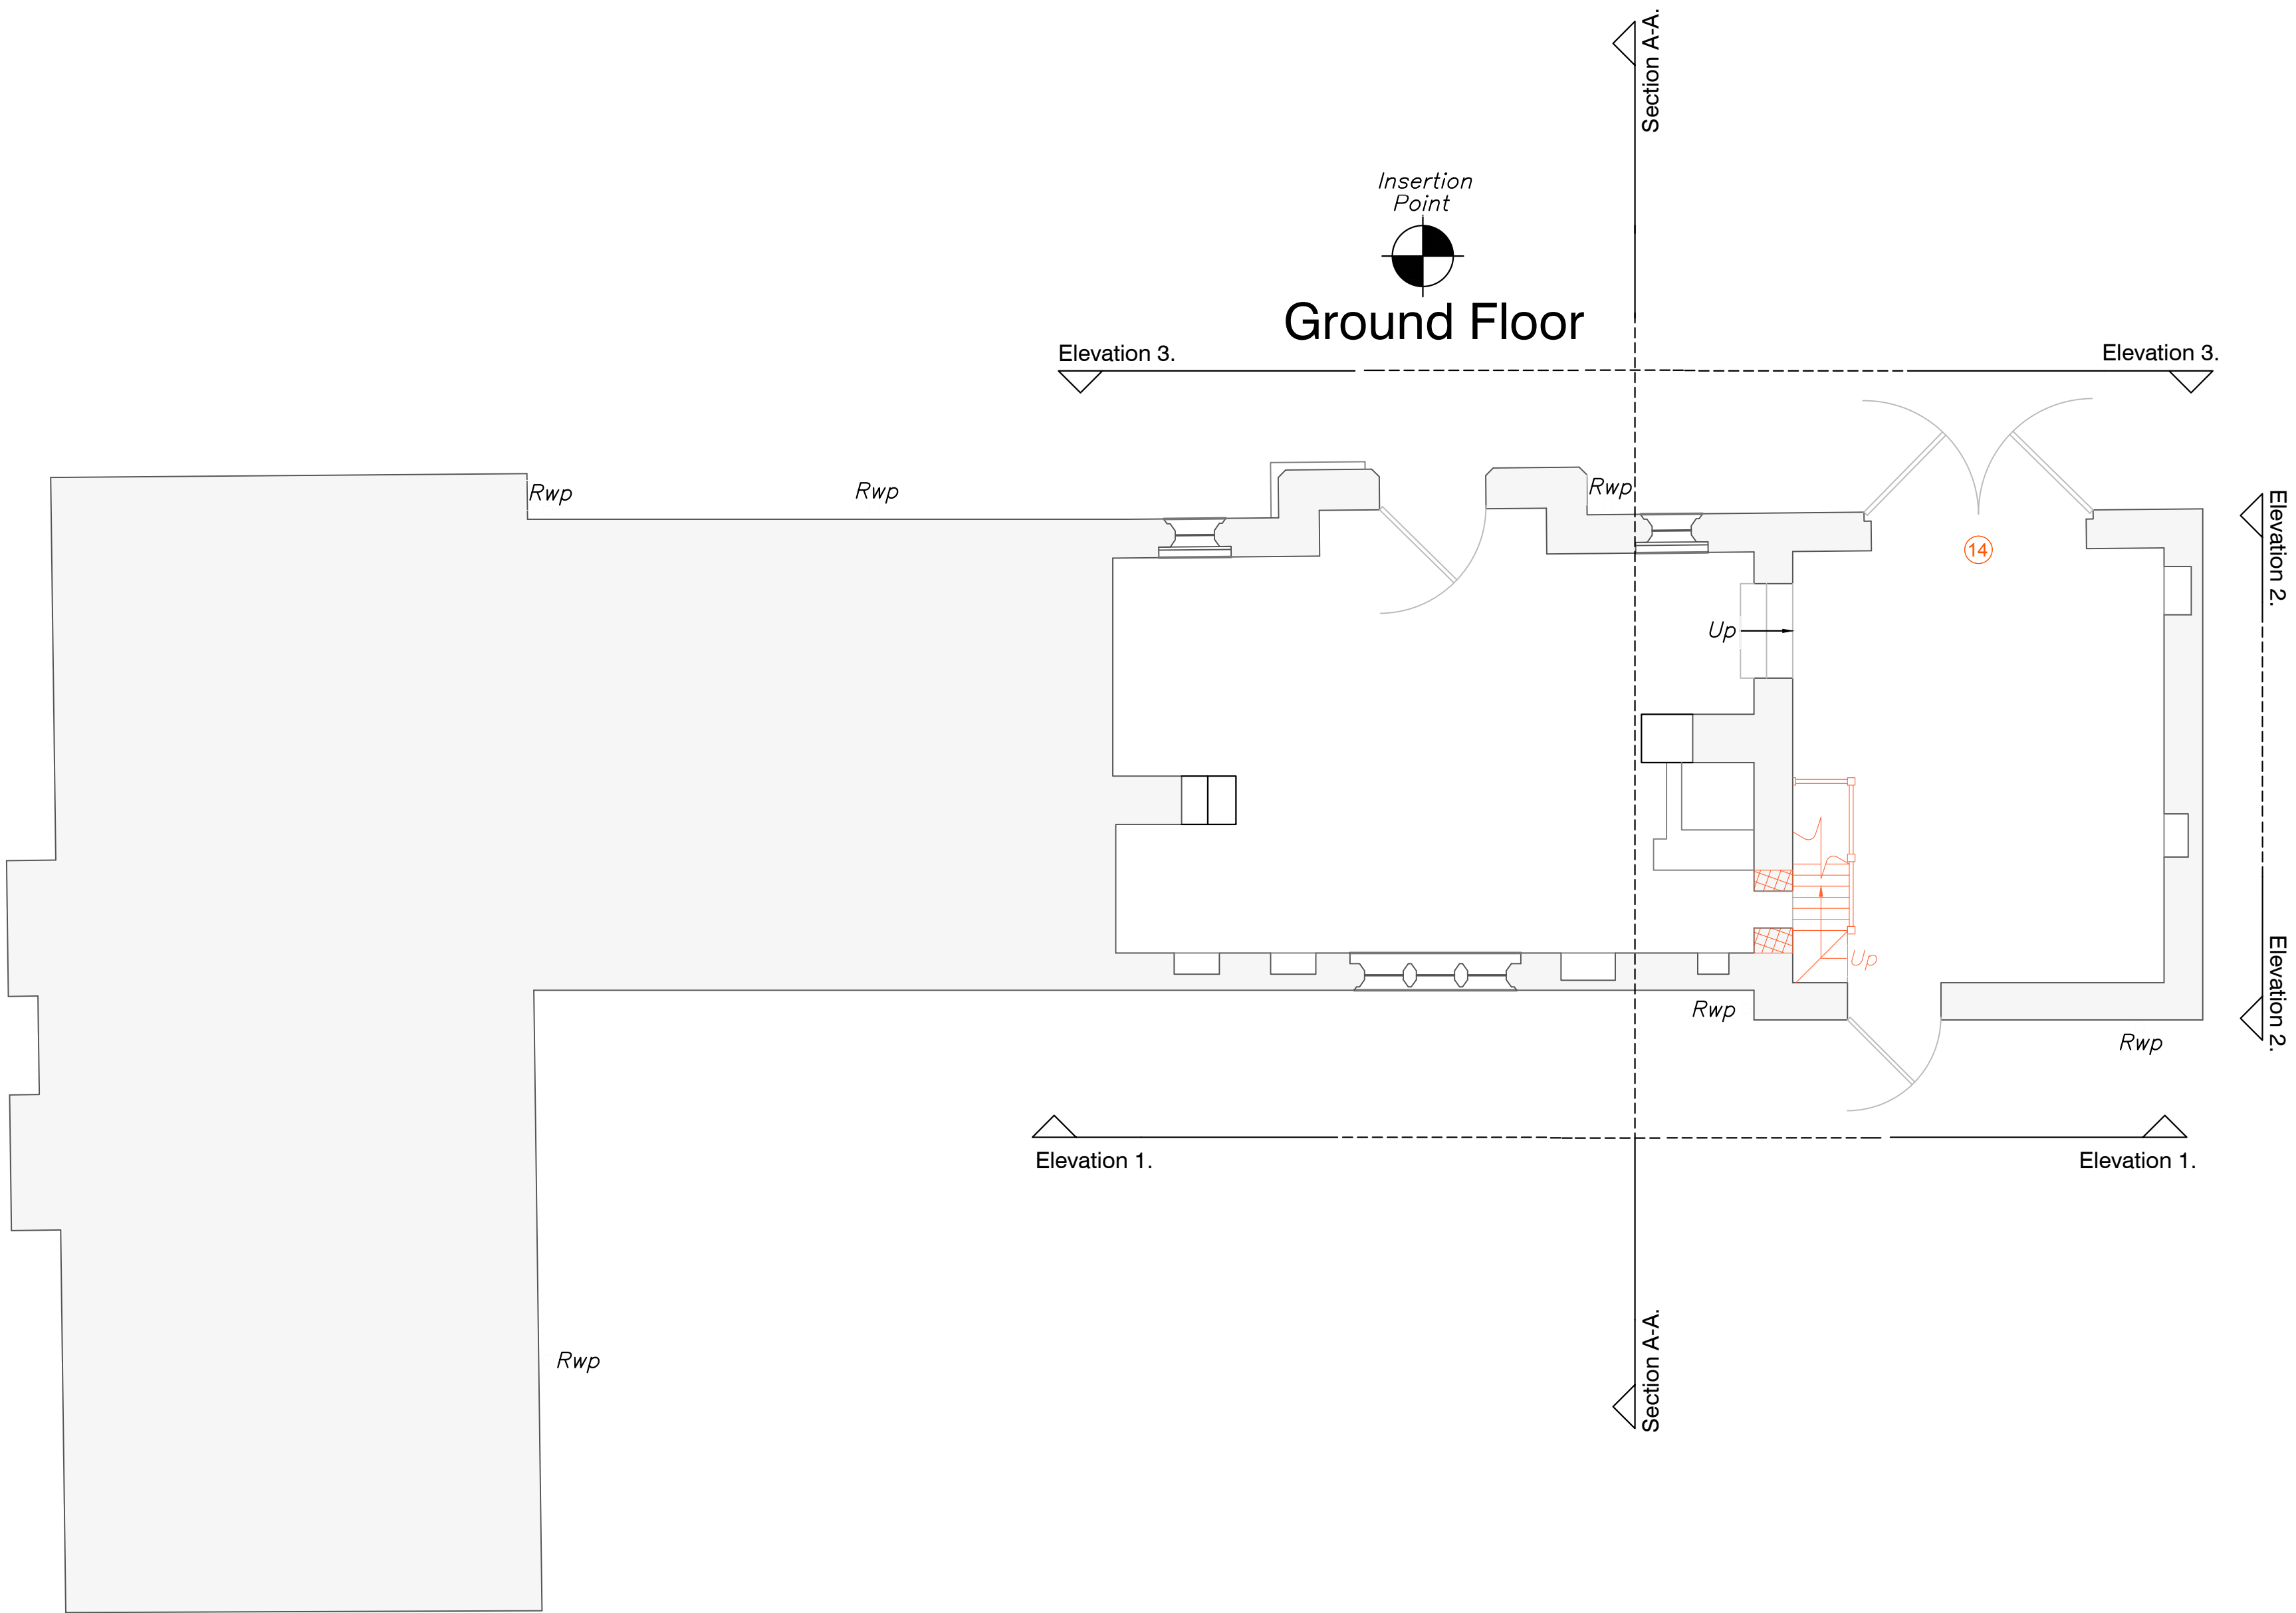
01

Existing doors and windows to be painted in Daylesford Green- Facia & Eaves boards
- 11

Existing gutters and RWP in poor condition to be replaced
- 12

Proposed timber window
- 14

Glass behind existing door
- Proposed demolition works
