Mr and Mrs Ford  
19 Hugo Street  
Lark  
ST13 3PE

Single storey rear extension

| Window Detail | | | |
| Drawn: <b>Architect</b> | Date: <b>23.03.2022</b> | Scale: <b>200%</b> | PL 04 |

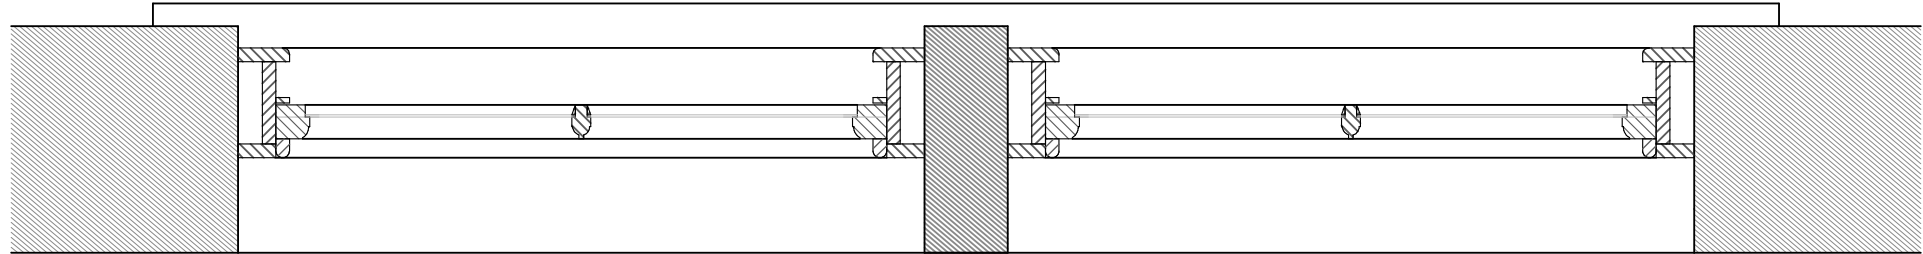
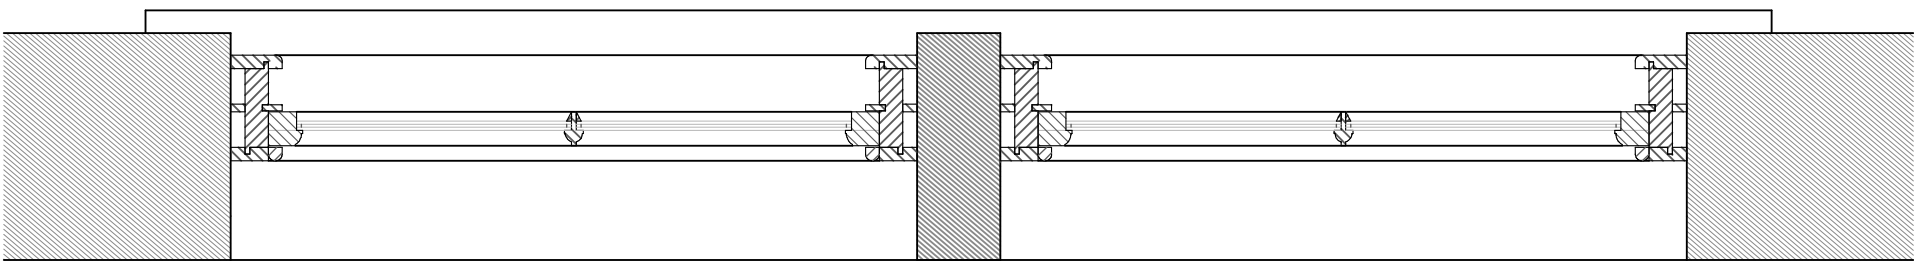
Window Section @ 1:10

Existing timber framed sliding sash window with single glazing and one vertical glazing bar per light.

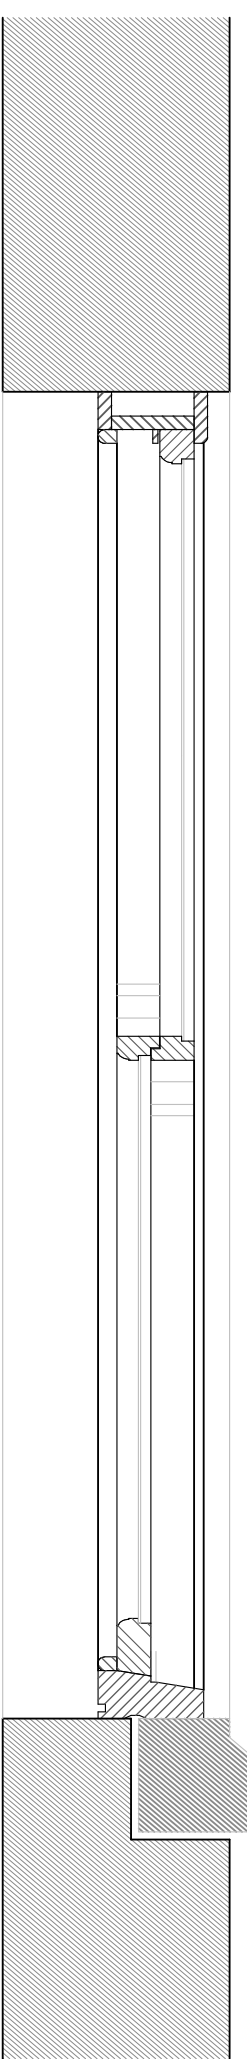
New timber framed sliding sash window with double glazing and one vertical glazing bar per light.
