**RE: Oakamoor Road, Cheadle – Garden Capping Validation Letter Plots 6 to 8**

Further to your instructions, GRM Development Solutions Ltd (GRM) attended site on the 31<sup>st</sup> May 2022 to validate the garden capping placed in the rear gardens of Plots 6 to 8 (inclusive).

**Validation Pit Location Plan  
Plots 6 to 8**

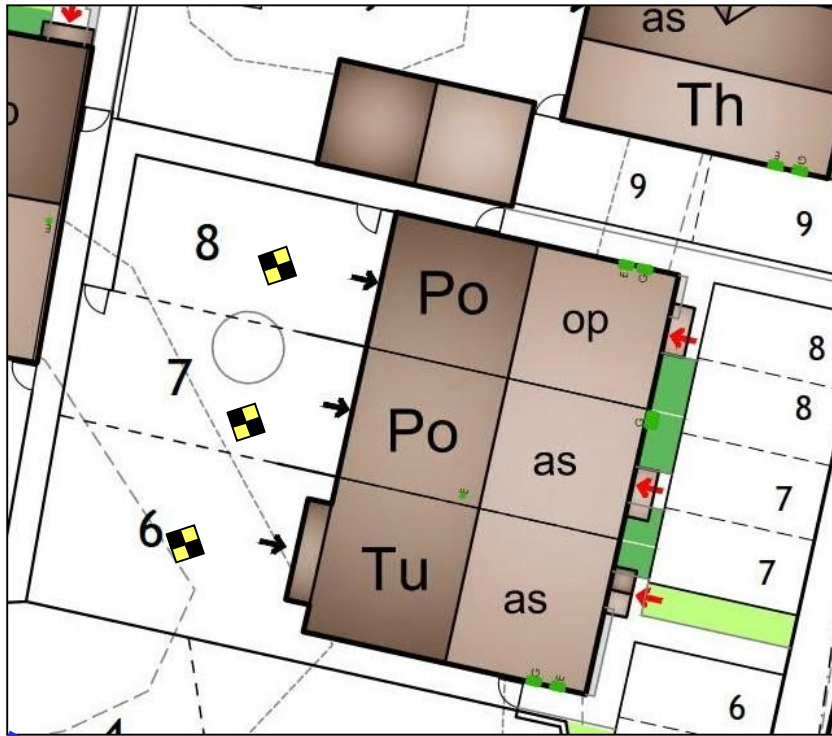
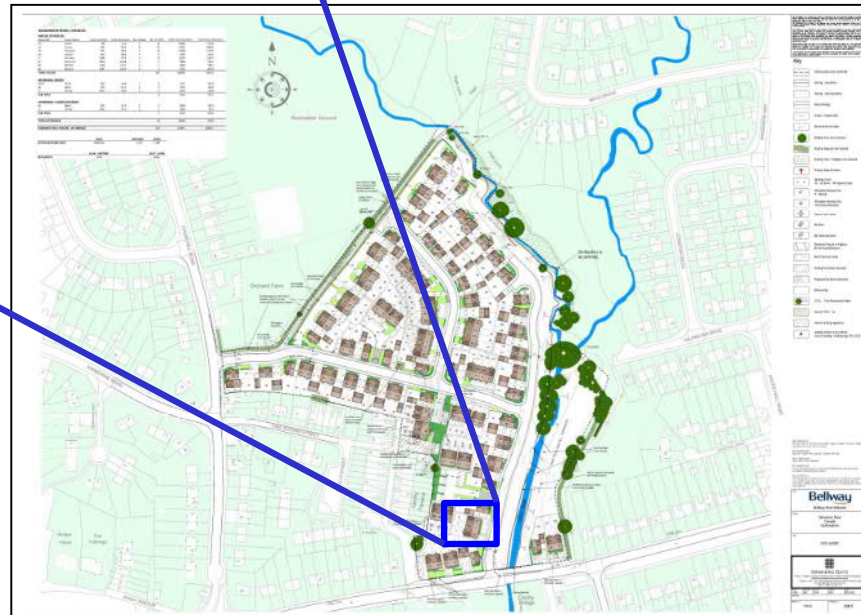
GRM excavated validation pits in each of the rear gardens of Plots 6 to 8 (inclusive) to confirm the depth of the capping layer. The breakdown of the capping layer is shown in Table 1 below. In summary, a soil capping layer between 600mm and 700mm in thickness was present within each garden with a minimum topsoil thickness of 450mm recorded. The Validation Pit Location Plan and Validation Photographs are shown in Appendix B.

Approx. location of capping validation pit.

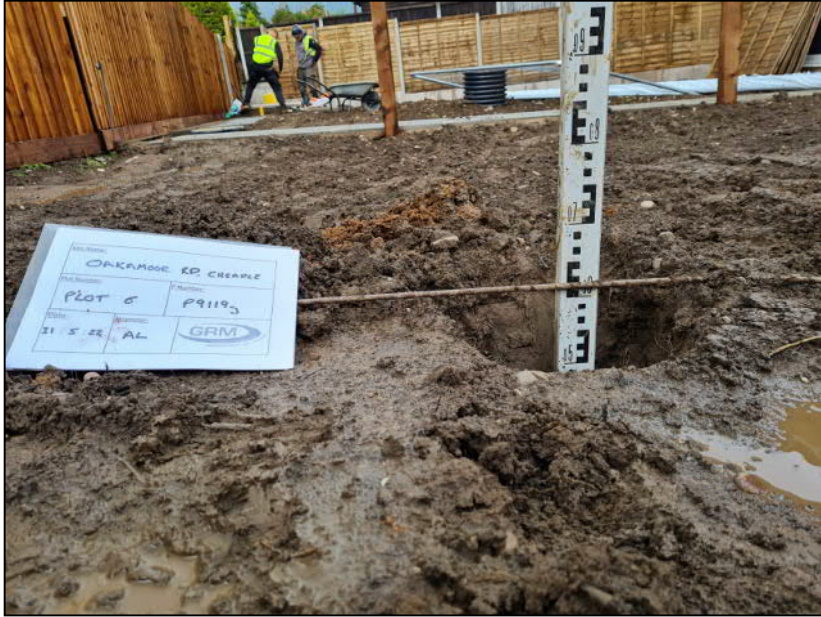
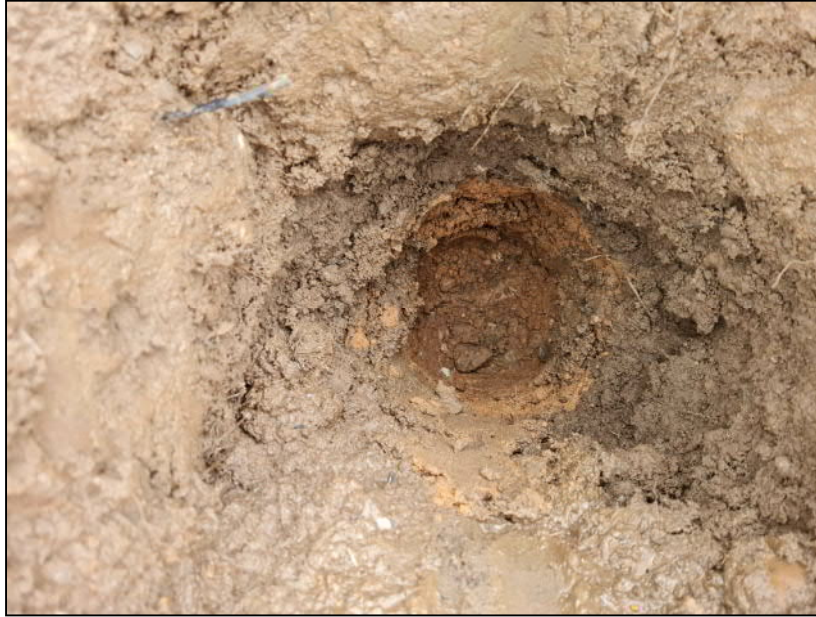
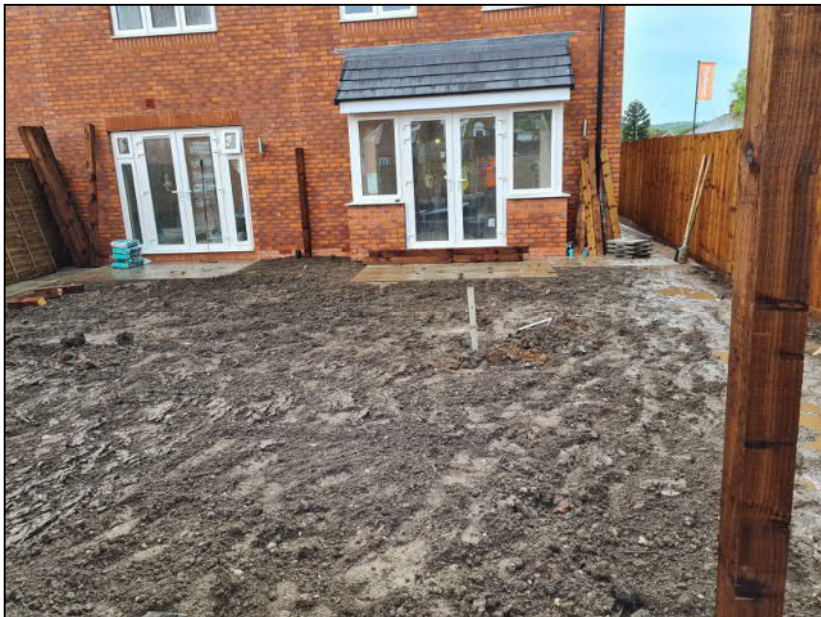
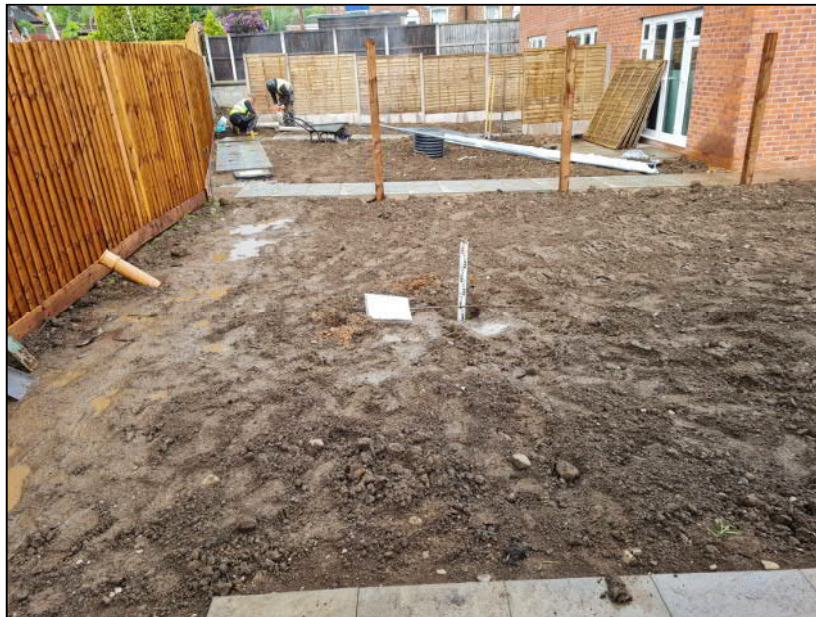
**Capping Validation Photos  
Plot 6**

| Plot | Topsoil Depth (mm) | Subsoil Depth (mm) |
|---|---|---|
| 6 | 500 | 150 |

**Validation undertaken on  
31<sup>st</sup> May 2022**

According to the above information the remedial measures are considered to comply with the agreed Remediation Strategy, and no further work is required.

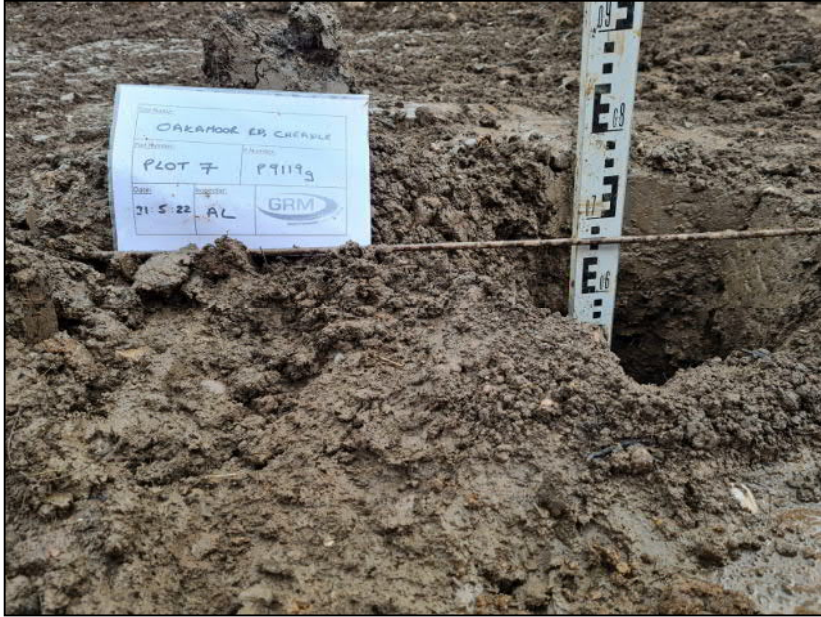
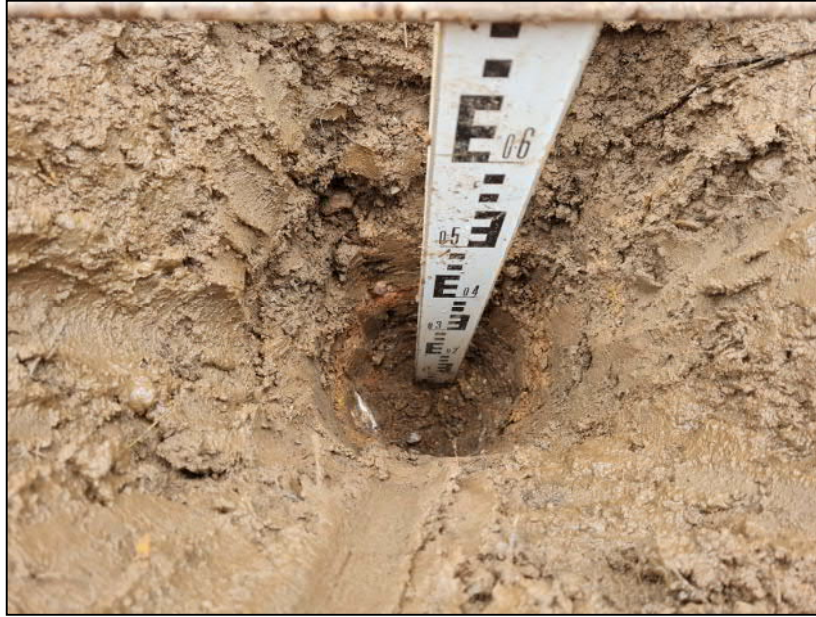
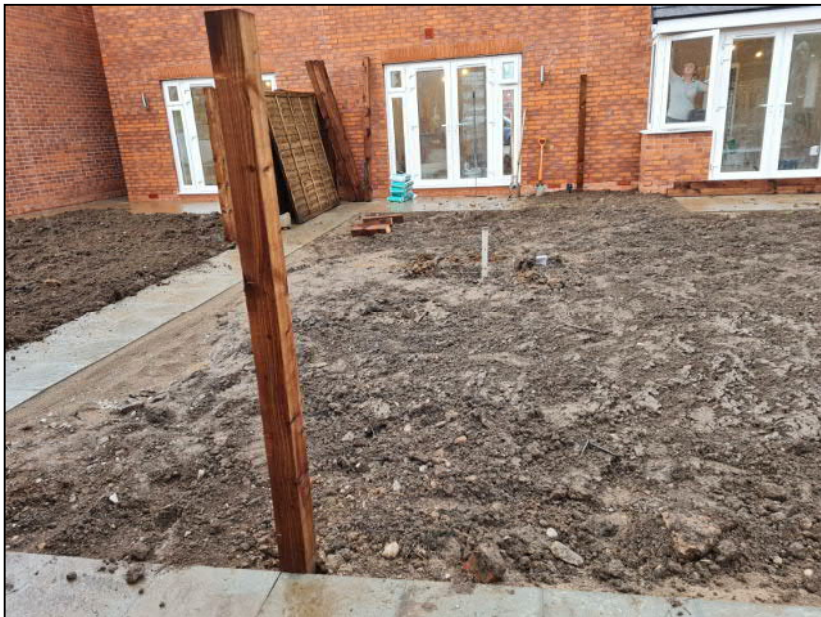
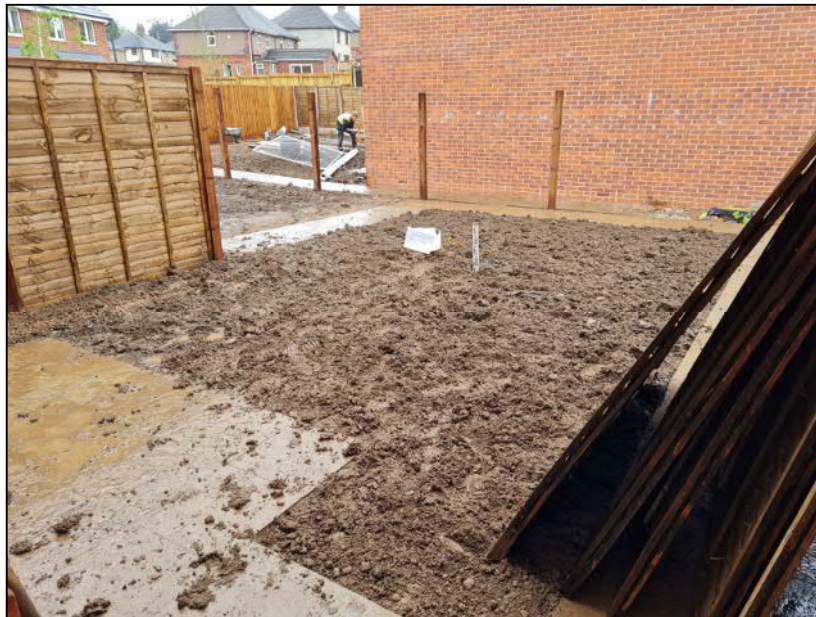
**Capping Validation Photos  
Plot 7**

| Plot | Topsoil Depth (mm) | Subsoil Depth (mm) |
|---|---|---|
| 7 | 450 | 250 |

**Validation undertaken on  
31<sup>st</sup> May 2022**

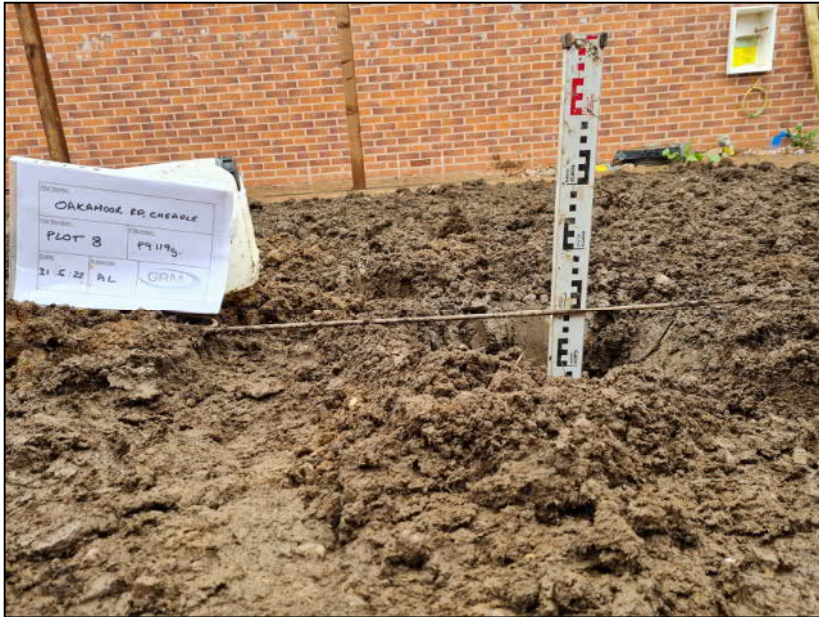
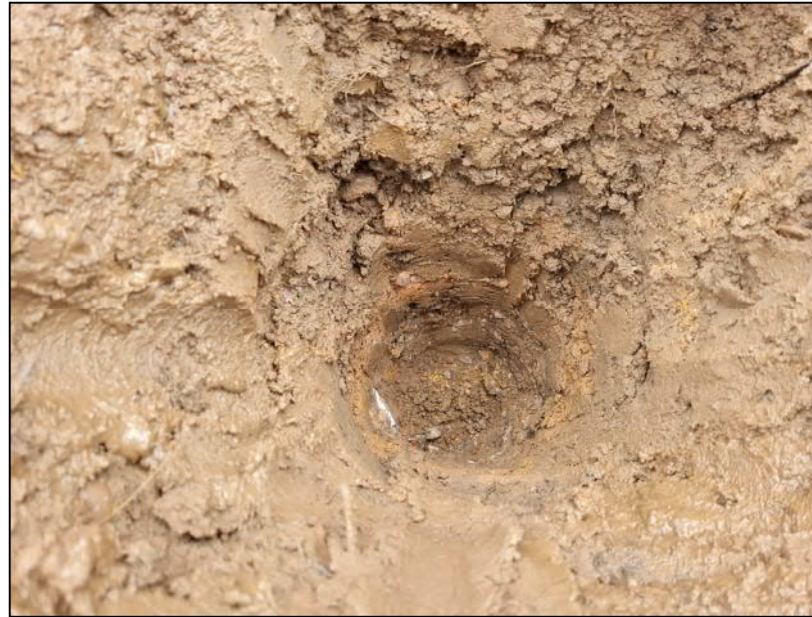
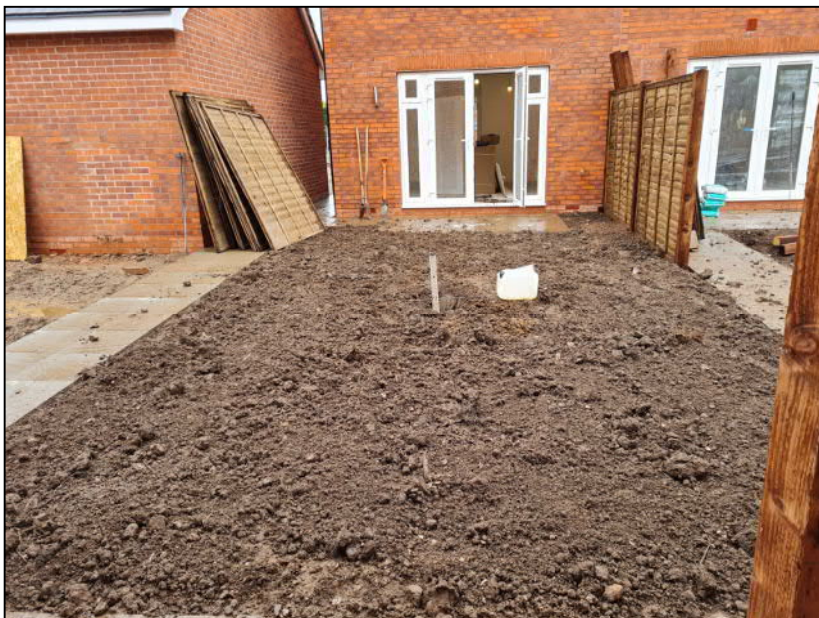
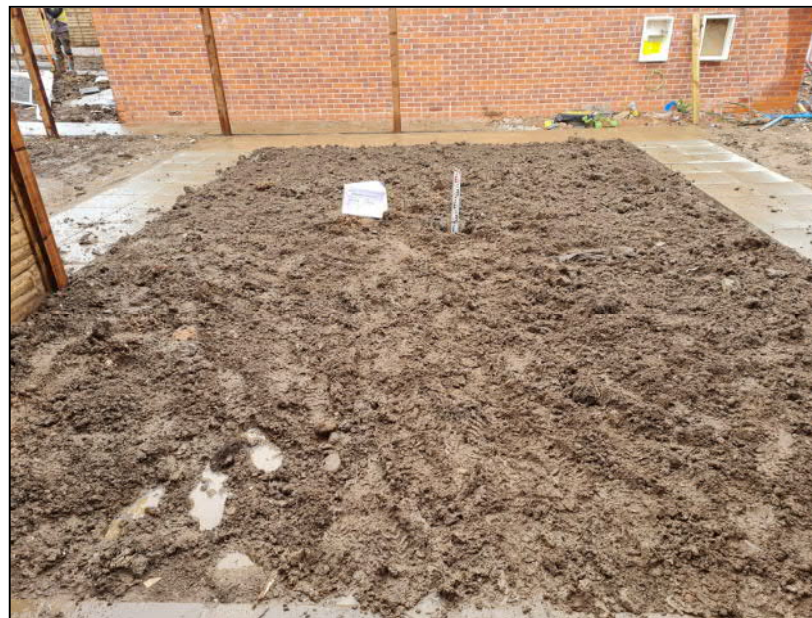
**Capping Validation Photos  
Plot 8**

| Plot | Topsoil Depth (mm) | Subsoil Depth (mm) |
|---|---|---|
| 8 | 500 | 100 |

**Validation undertaken on  
31<sup>st</sup> May 2022**
