02  
Existing Elevation 3  
1:50

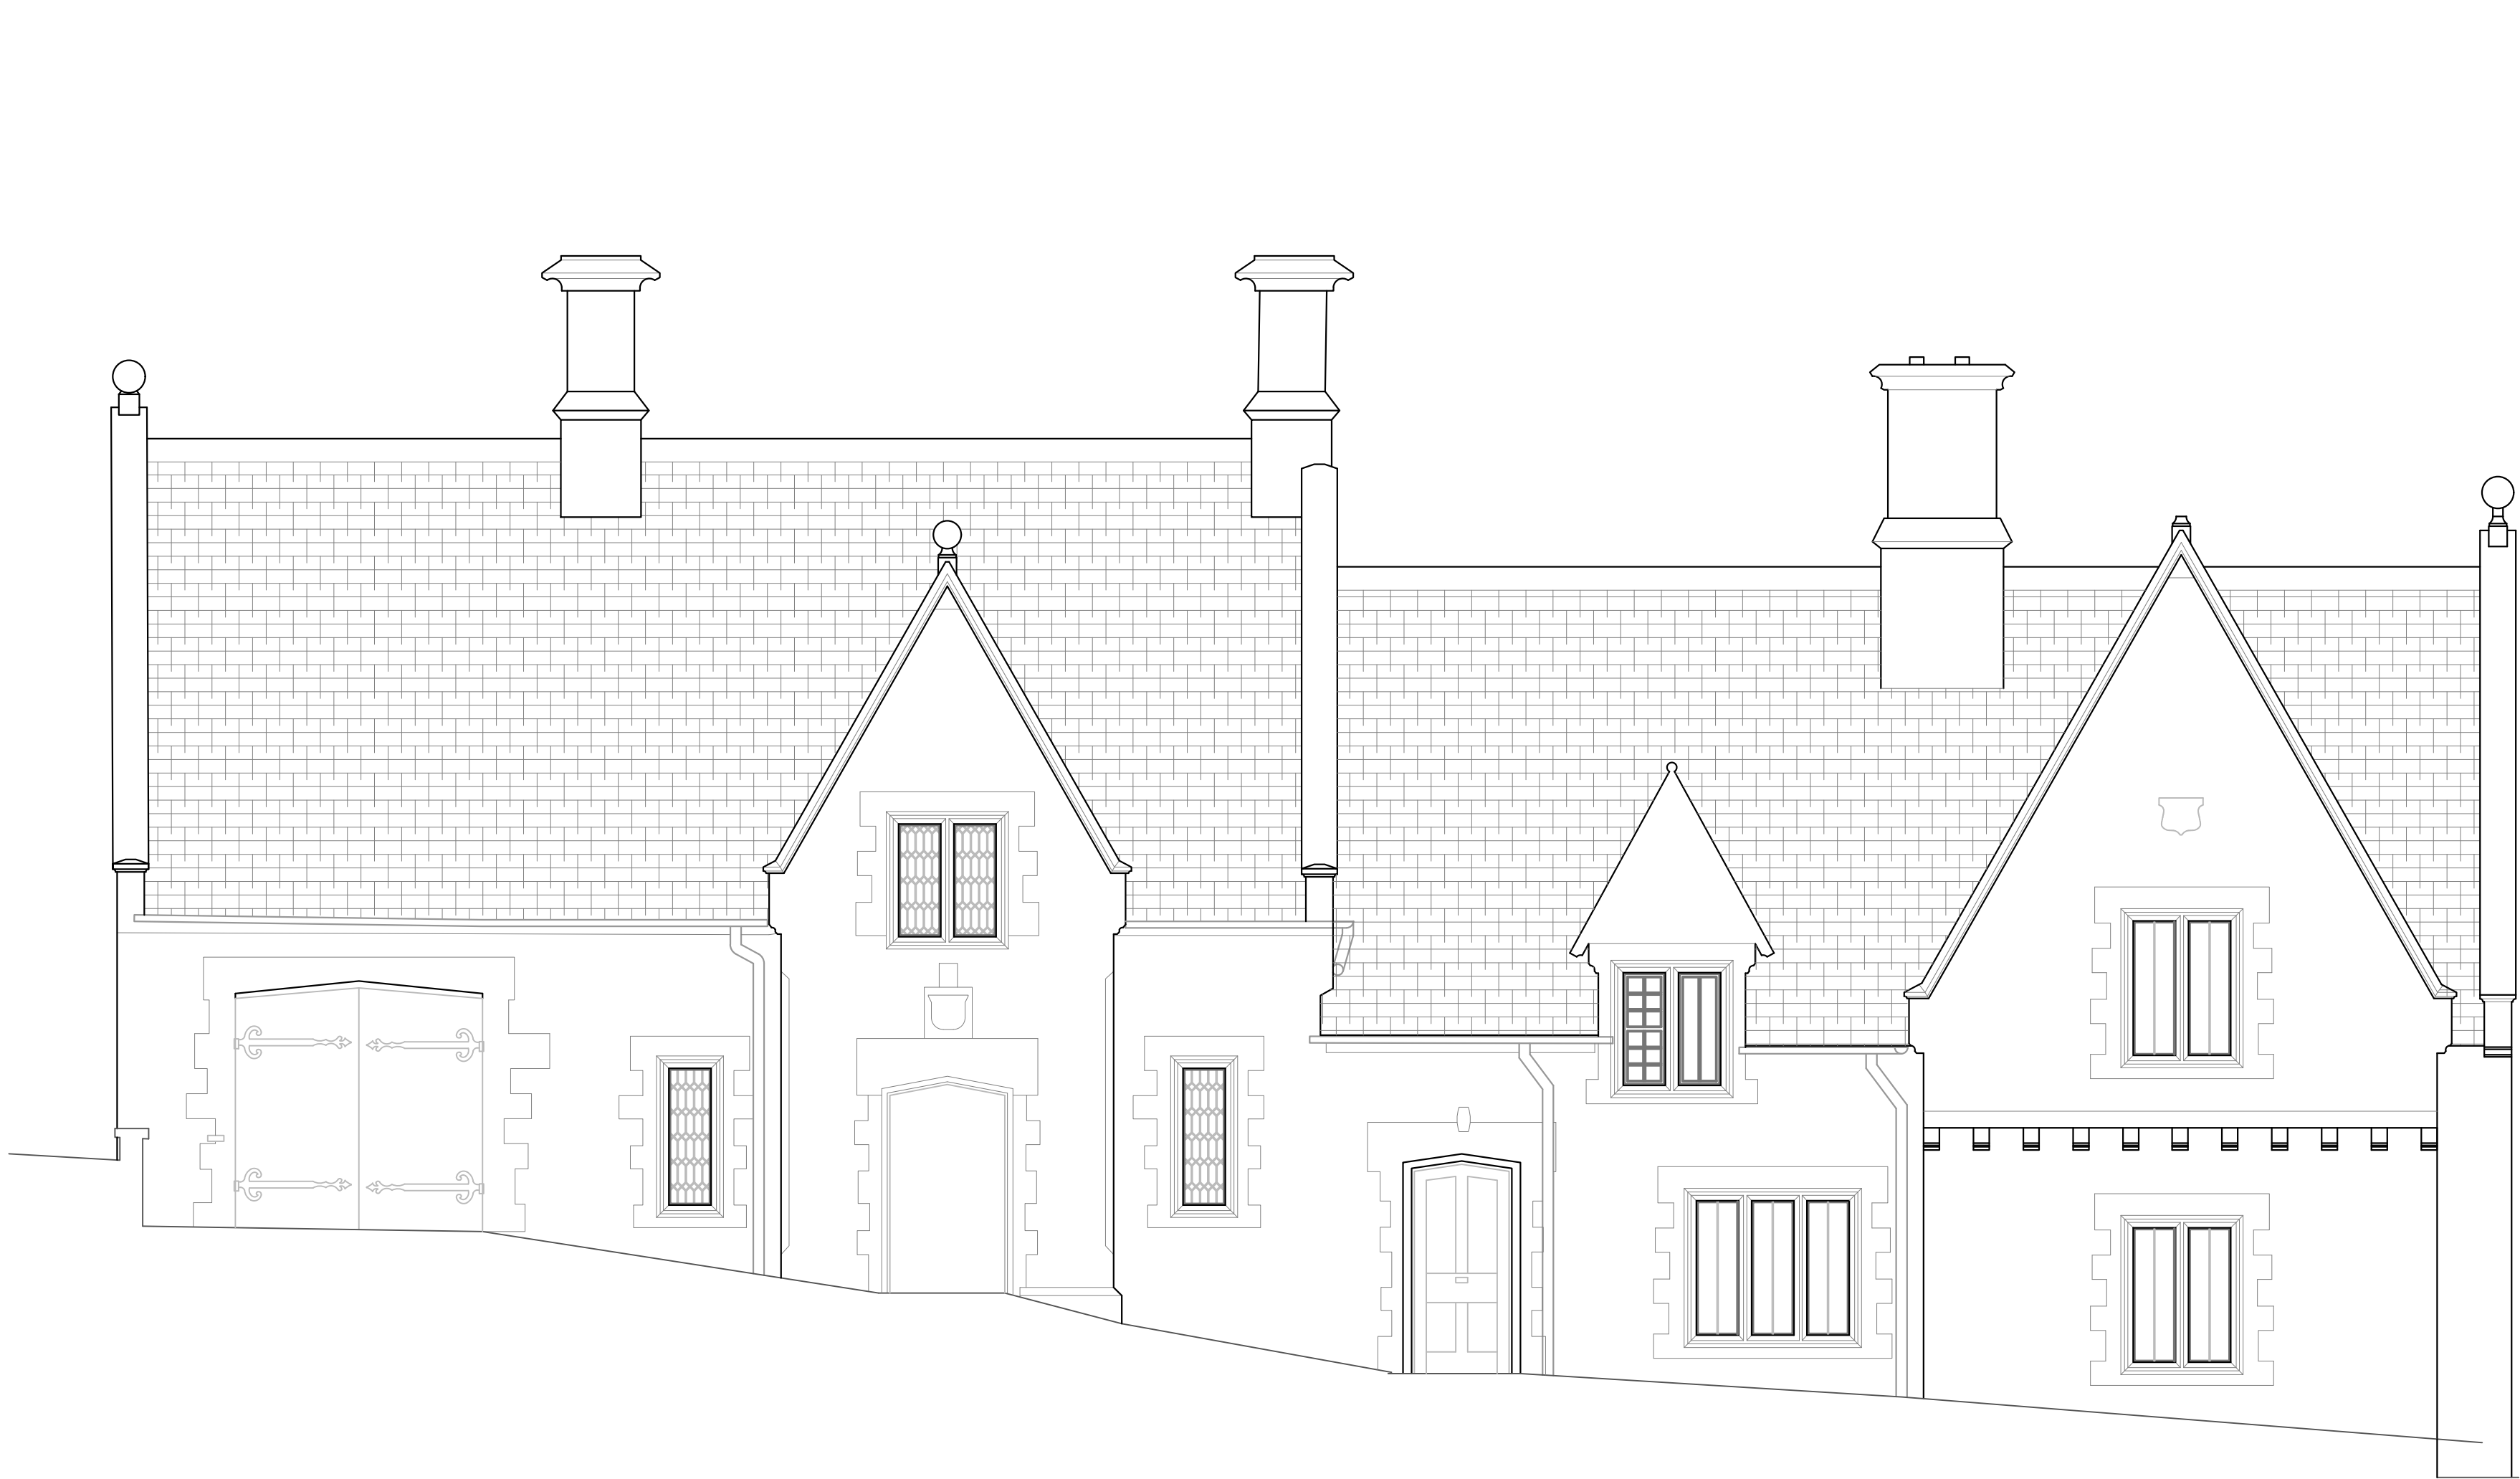
Partition wall to be demolished
- 07

Structural opening to be formed
- External works
- 10

Existing doors and windows to be painted in Daylesford Green- Facia & Eaves boards
- 11

Existing gutters and RWP in poor condition to be replaced
- 12

Proposed timber window
- Proposed demolition works

Datum: 195.00m.  
Elevation 3.
