MISS WILSON'S  
EXISTING ELEVATION 4  
1690.07\_120\_03  
STATUS: Issued for Tender  
DATE: October 2021  
SCALE: 1:50 @ A1  
DRAWN: AG  
CHECKED: AC  
CLIENT:  
daylesford  
ORGANIC FARM ORGANICESTERSHIRE  
Miss Wilson's, Farley, Staffordshire ST10 3BQ

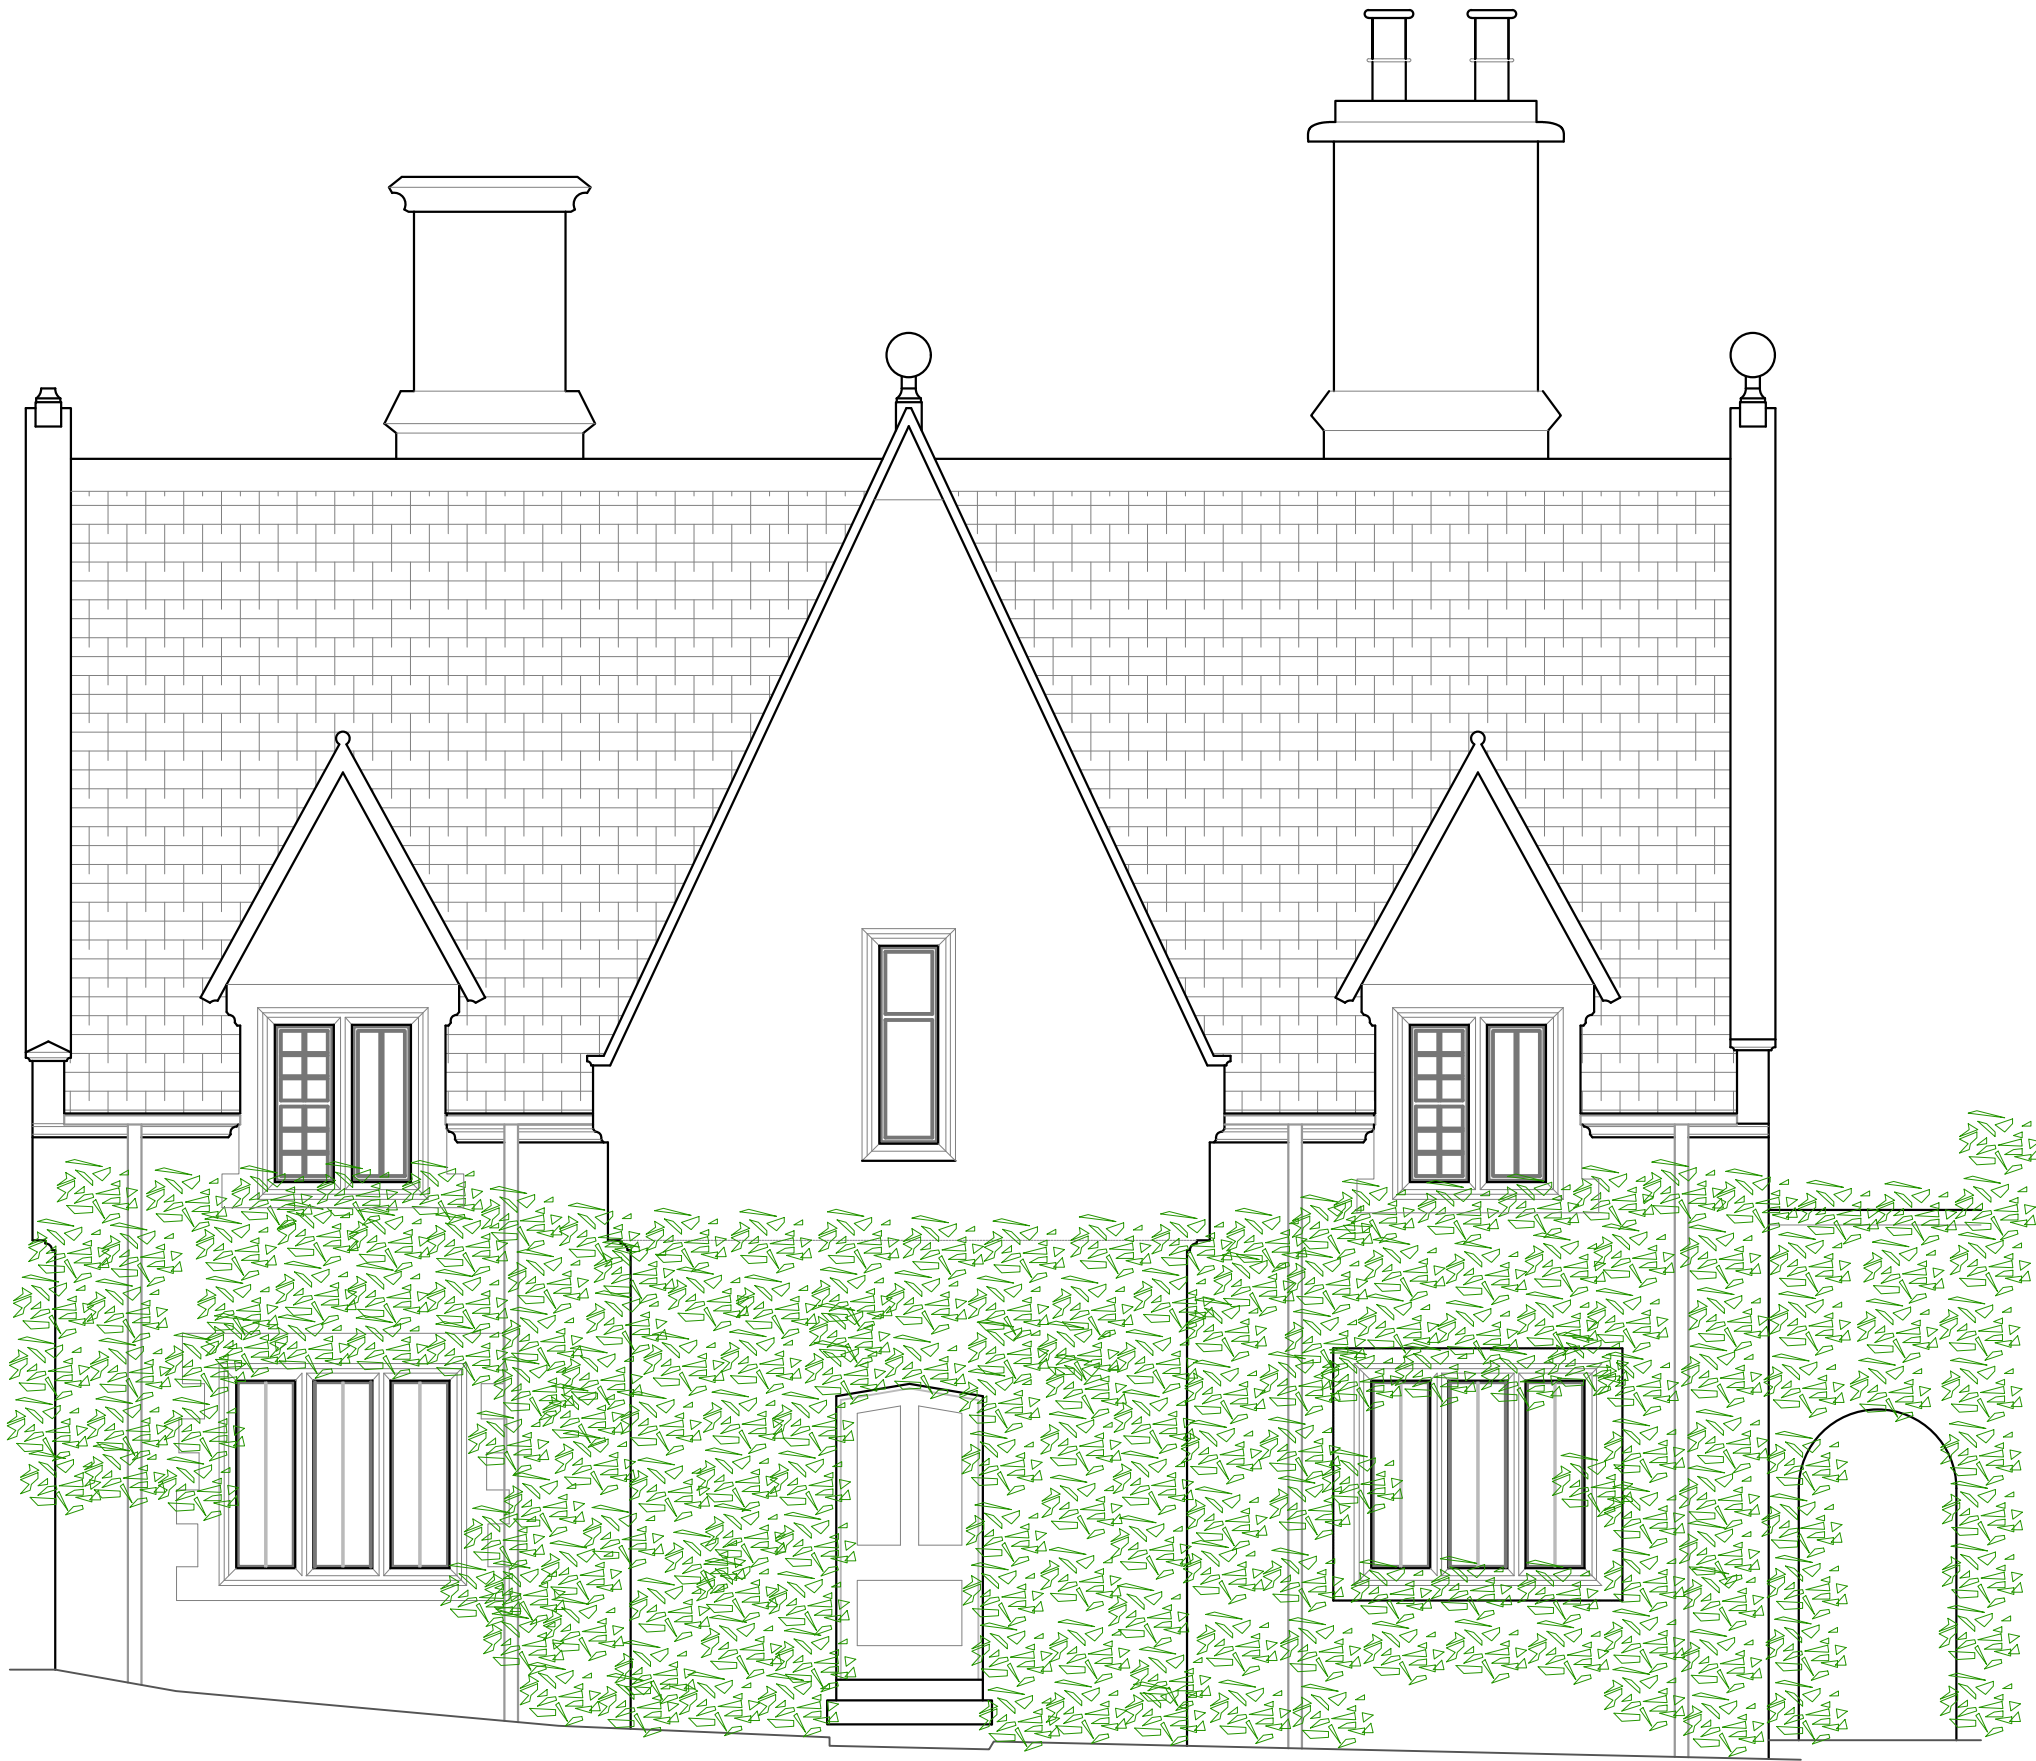
03  
Existing Elevation 4  
1:50

Partition wall to be demolished
- 07

Structural opening to be formed
- External works
- 10

Existing doors and windows to be painted in Daylesford Green- Facia & Eaves boards
- 11

Existing gutters and RWP in poor condition to be replaced
- 12

Proposed timber window
- Proposed demolition works

Datum: 195.00m.  
Elevation 4.
