RIBA WORKSTAGE / STATUS 3 / Planning

PROJECT  
Barn Reconstruction,  
Draycott

TITLE  
Existing Elevations 2

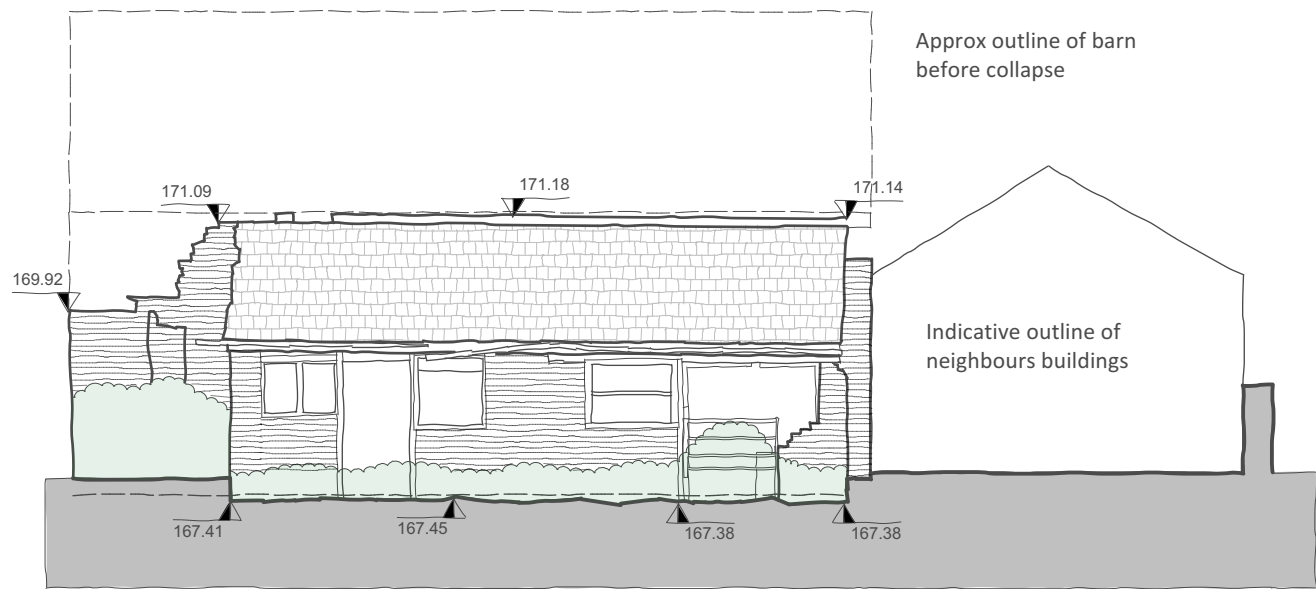
ELEVATION 3

DATUM: 165.00m

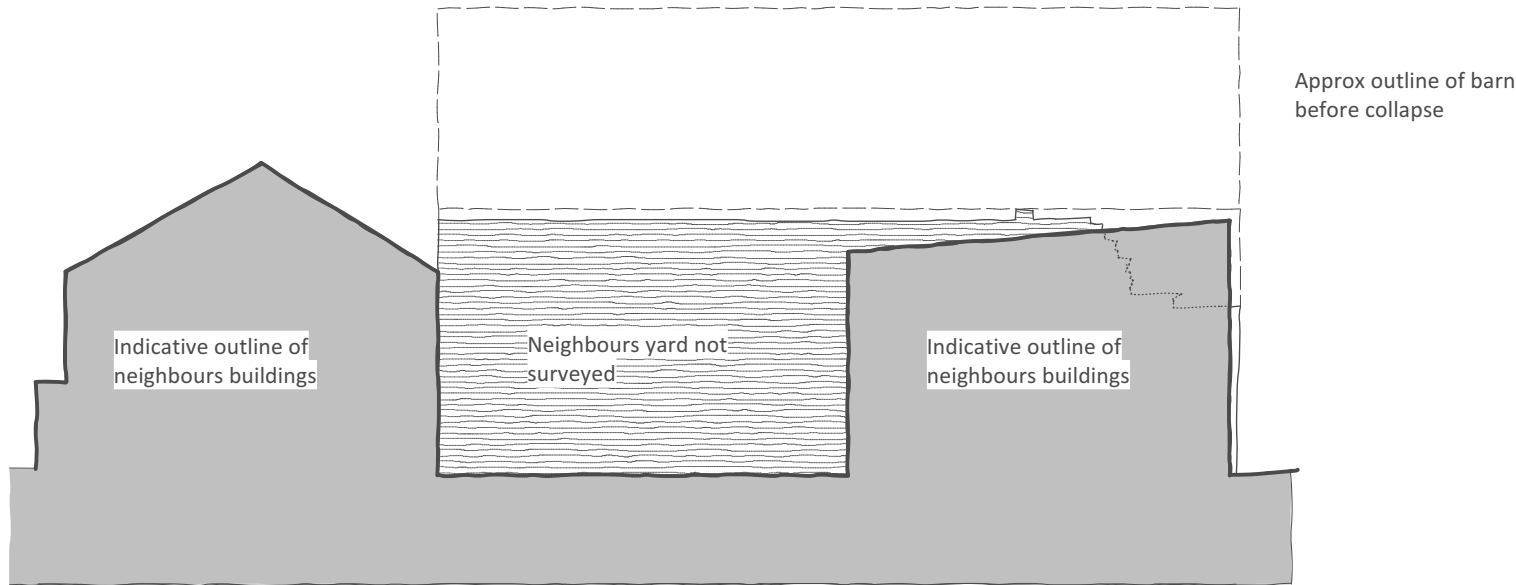
ELEVATION 4

DATUM: 165.00m
