SIDE ELEVATION 1:50  
FACING EAST STREET.

FRONT ELEVATION 1:50

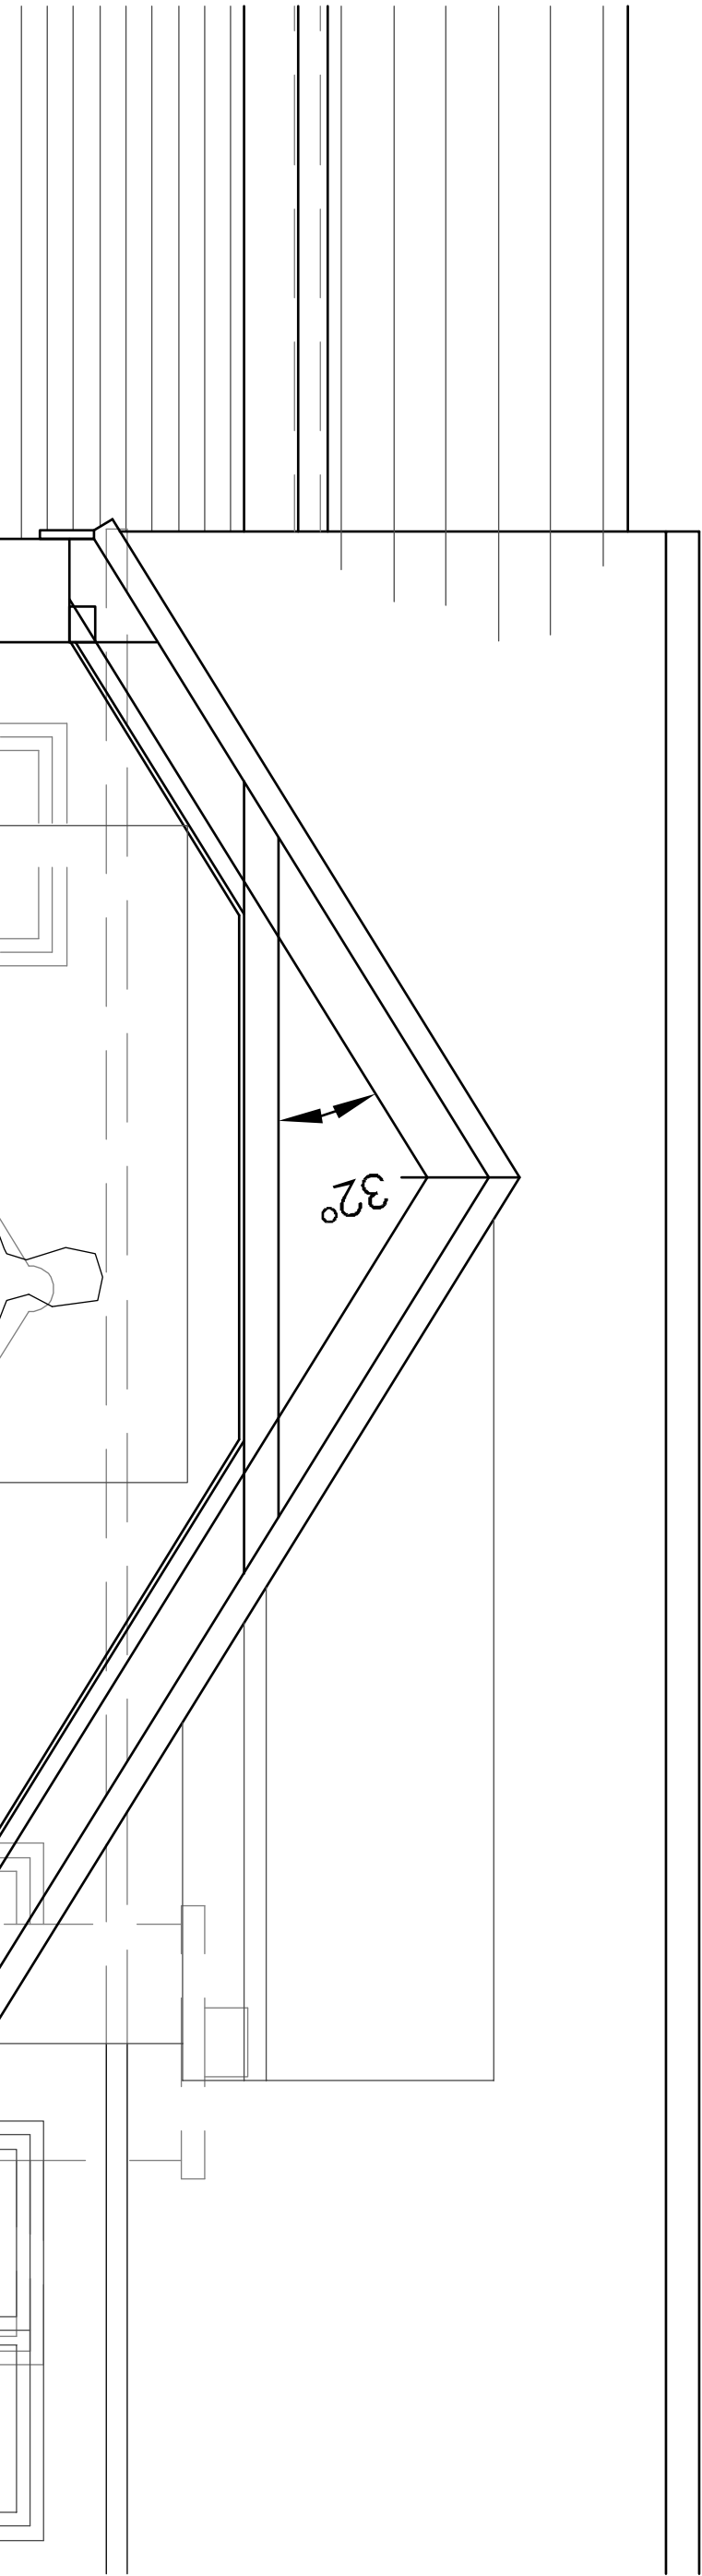
New oak entrance porch to dwelling, main entrance to dwelling has now been relocated.

New reclin bricks to re-skin parts of the existing dwelling to better match surround area as Fountain Cottage is the only rendered house on East Street.

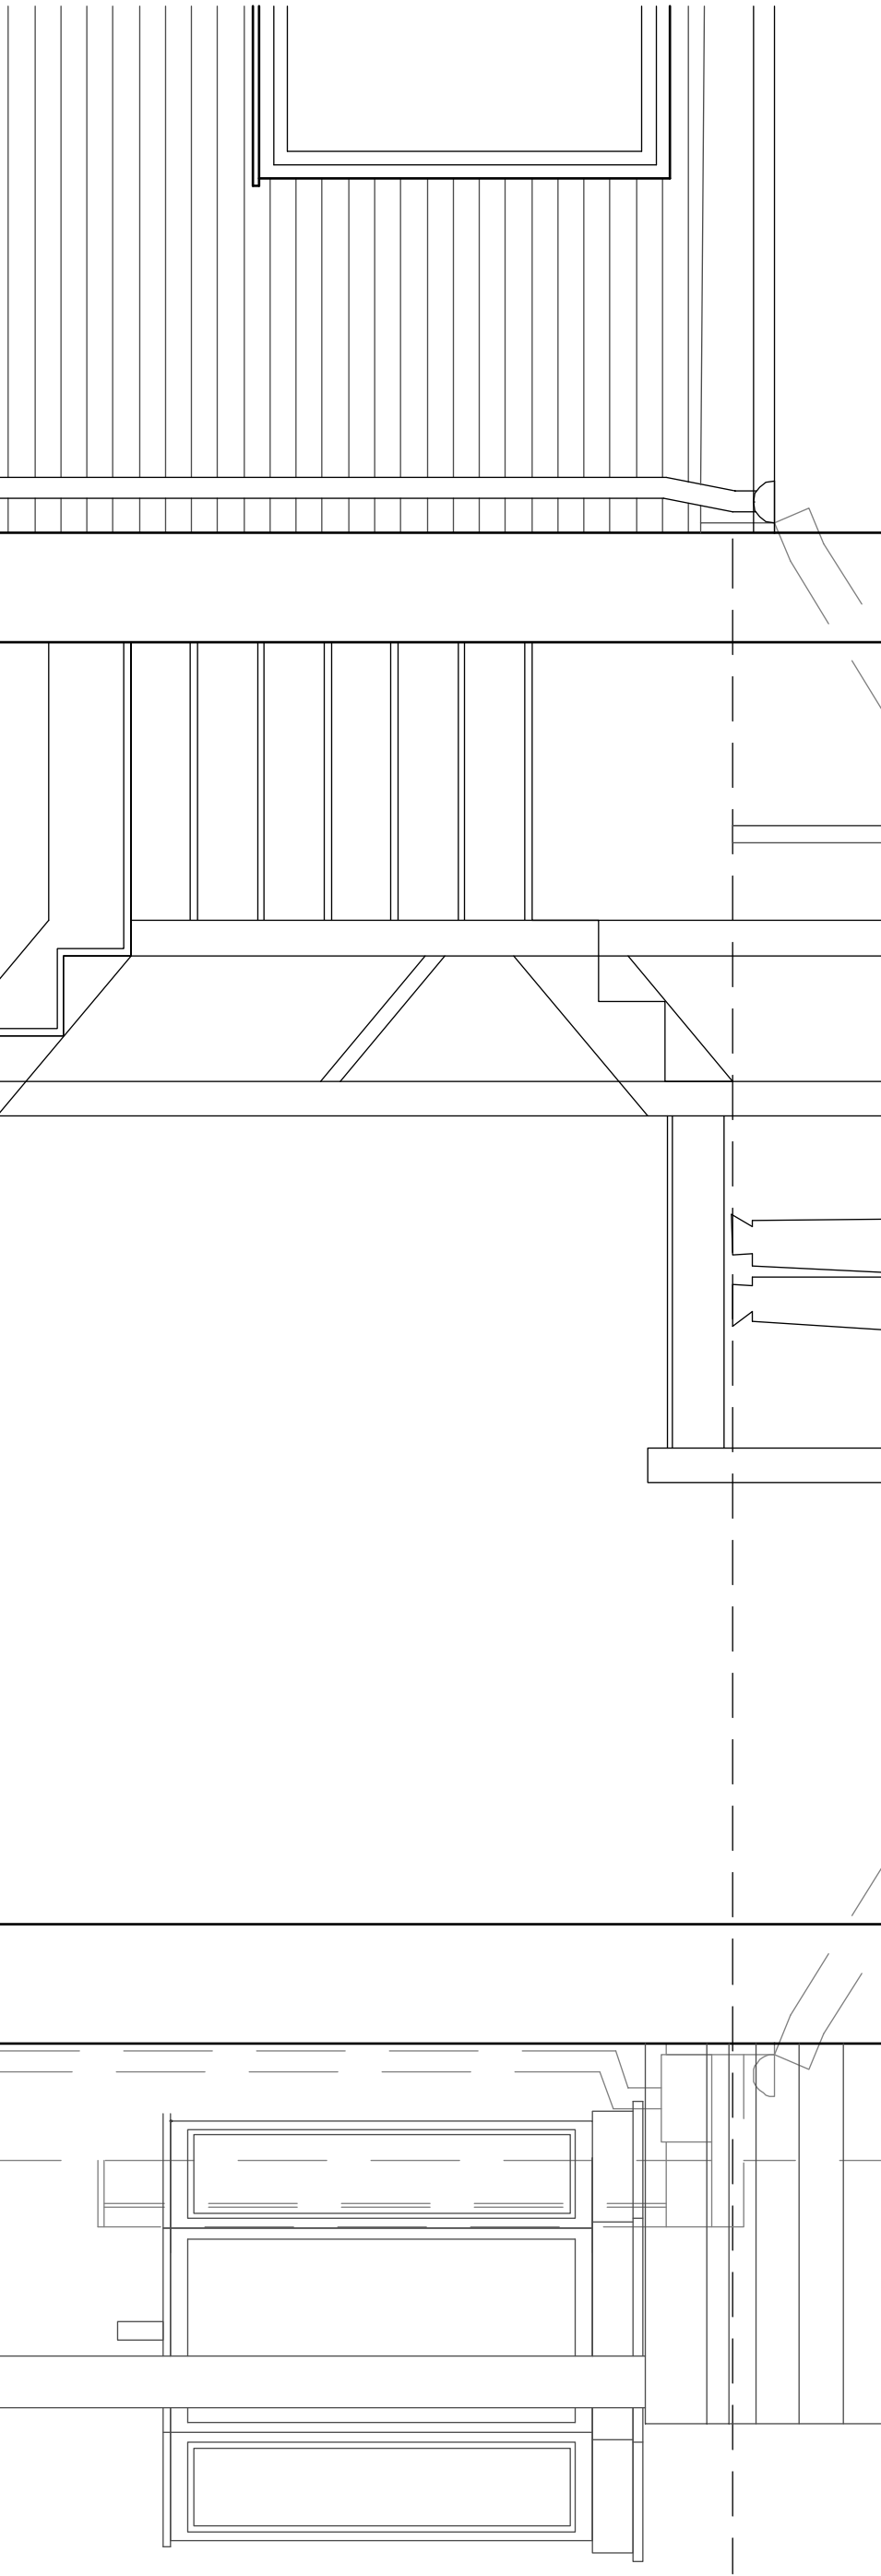
New render finish to match existing

New reclin bricks to re-skin parts of the existing dwelling to better match surround area as Fountain Cottage is the only rendered house on East Street.

Roof tiles to match existing

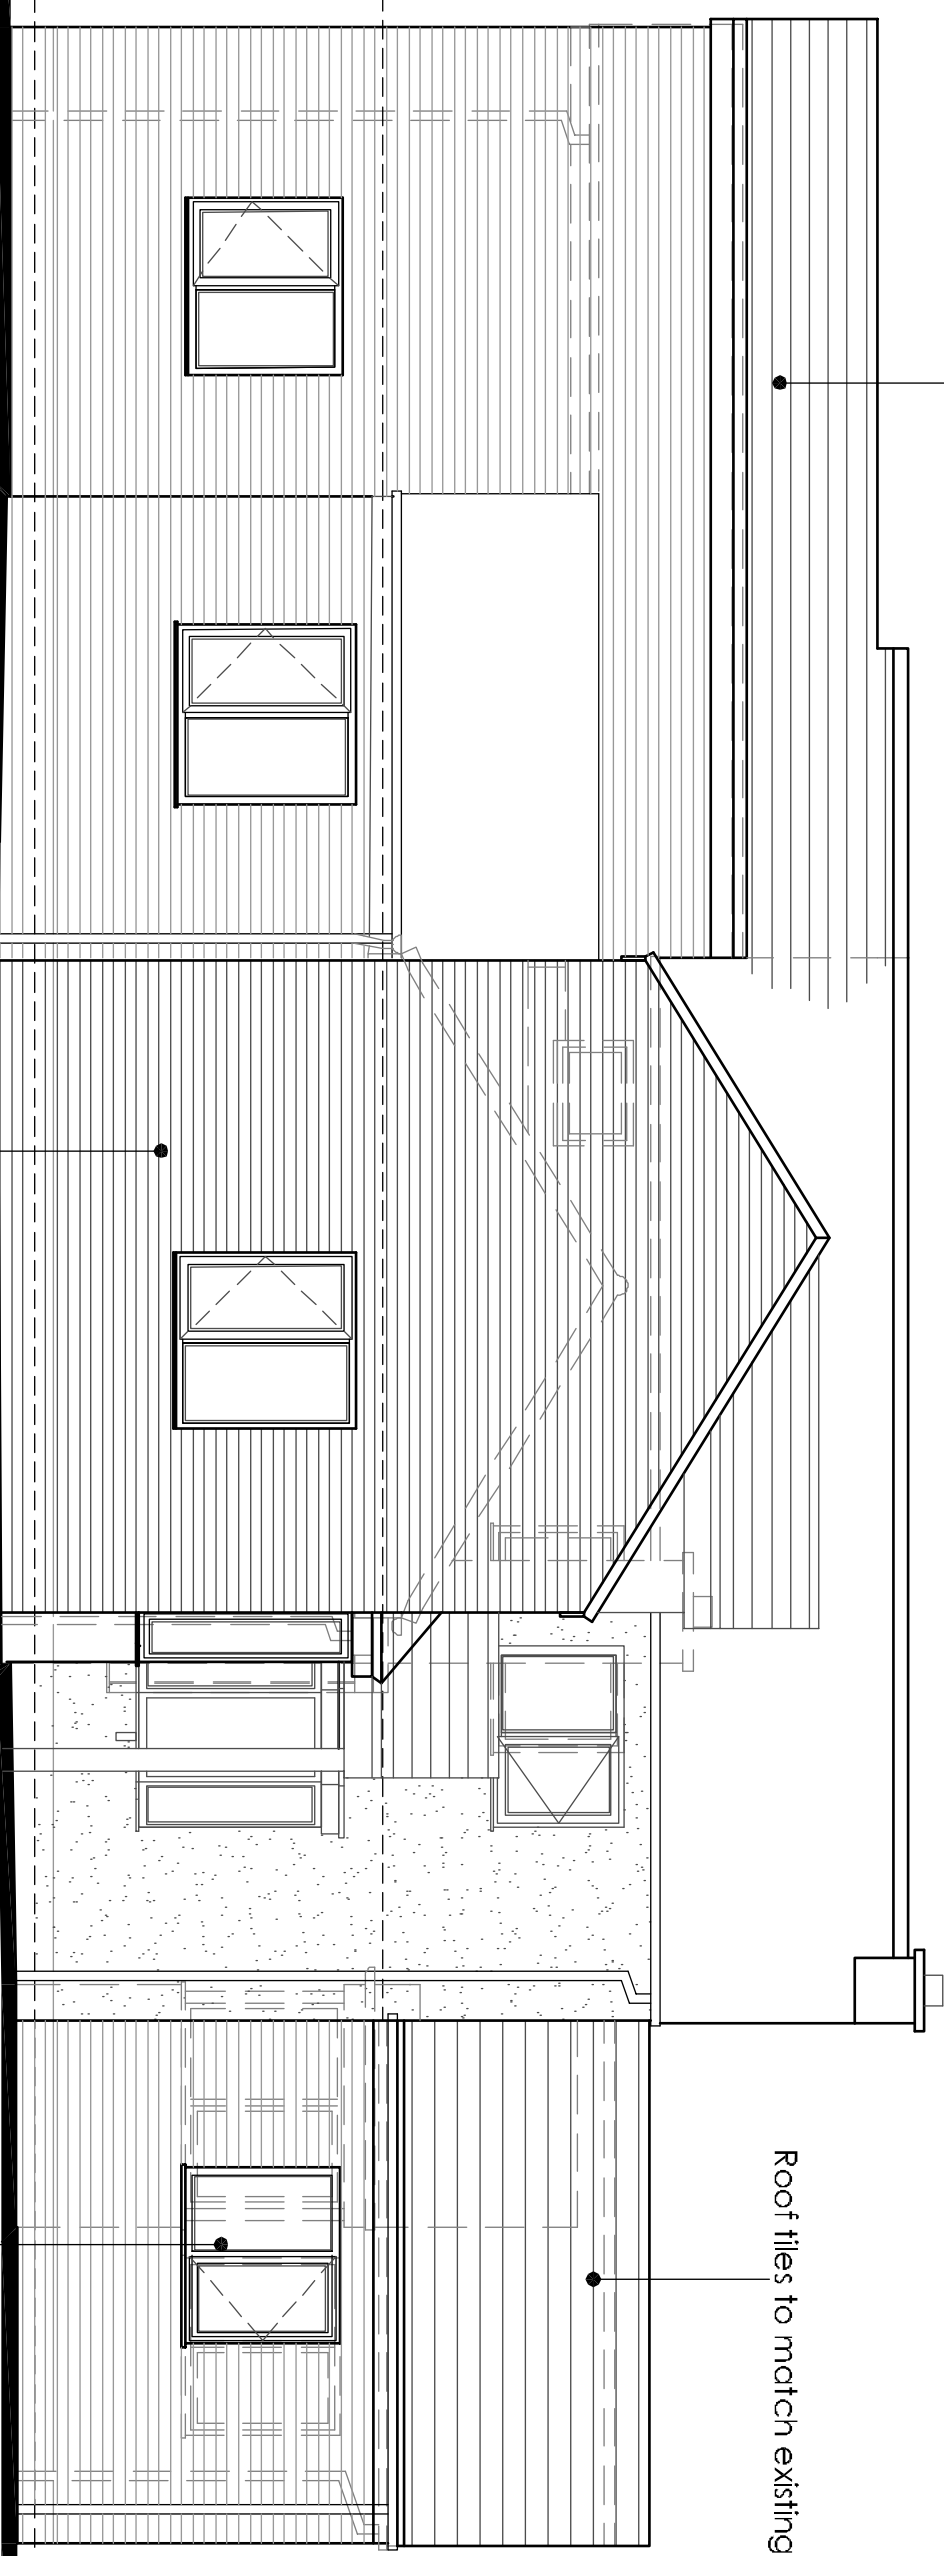
REAR ELEVATION 1:50

New reclin bricks to re-skin parts of the existing dwelling to better match surround area as Fountain Cottage is the only rendered house on East Street.

New oak entrance porch to dwelling, main entrance to dwelling has now been relocated.

New windows to be UPVC to match existing
