Client  
Alton Towers Resort

Alton Towers Resort  
Farley Lane  
Alton  
ST10 4DB

Deer Wall Protection Detail

ATPO-SA-FV-XX-DR-A-0601

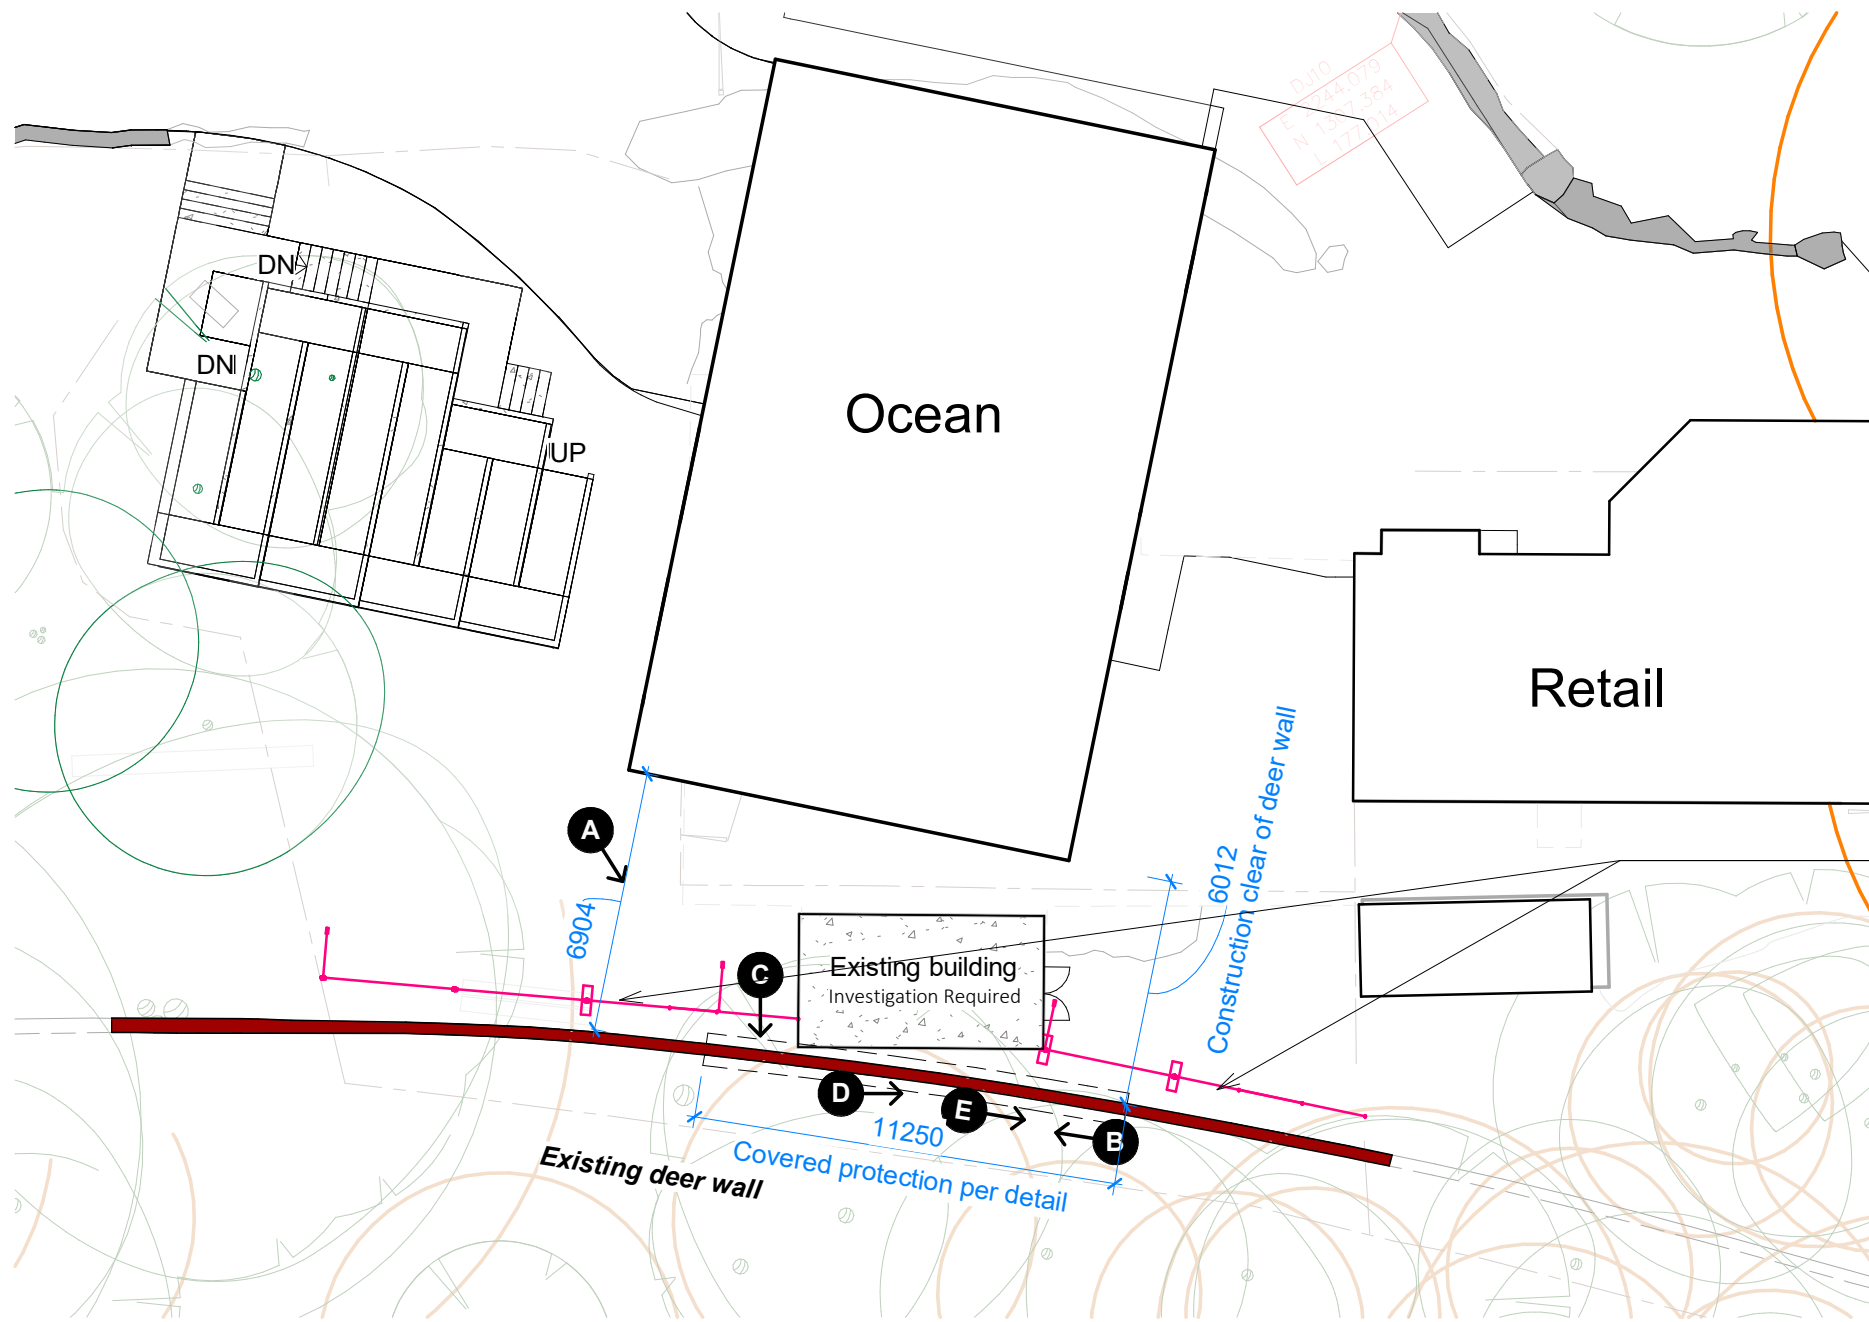
1 Deer Wall Protection Plan  
1 : 200

Extent of deer wall to be protected

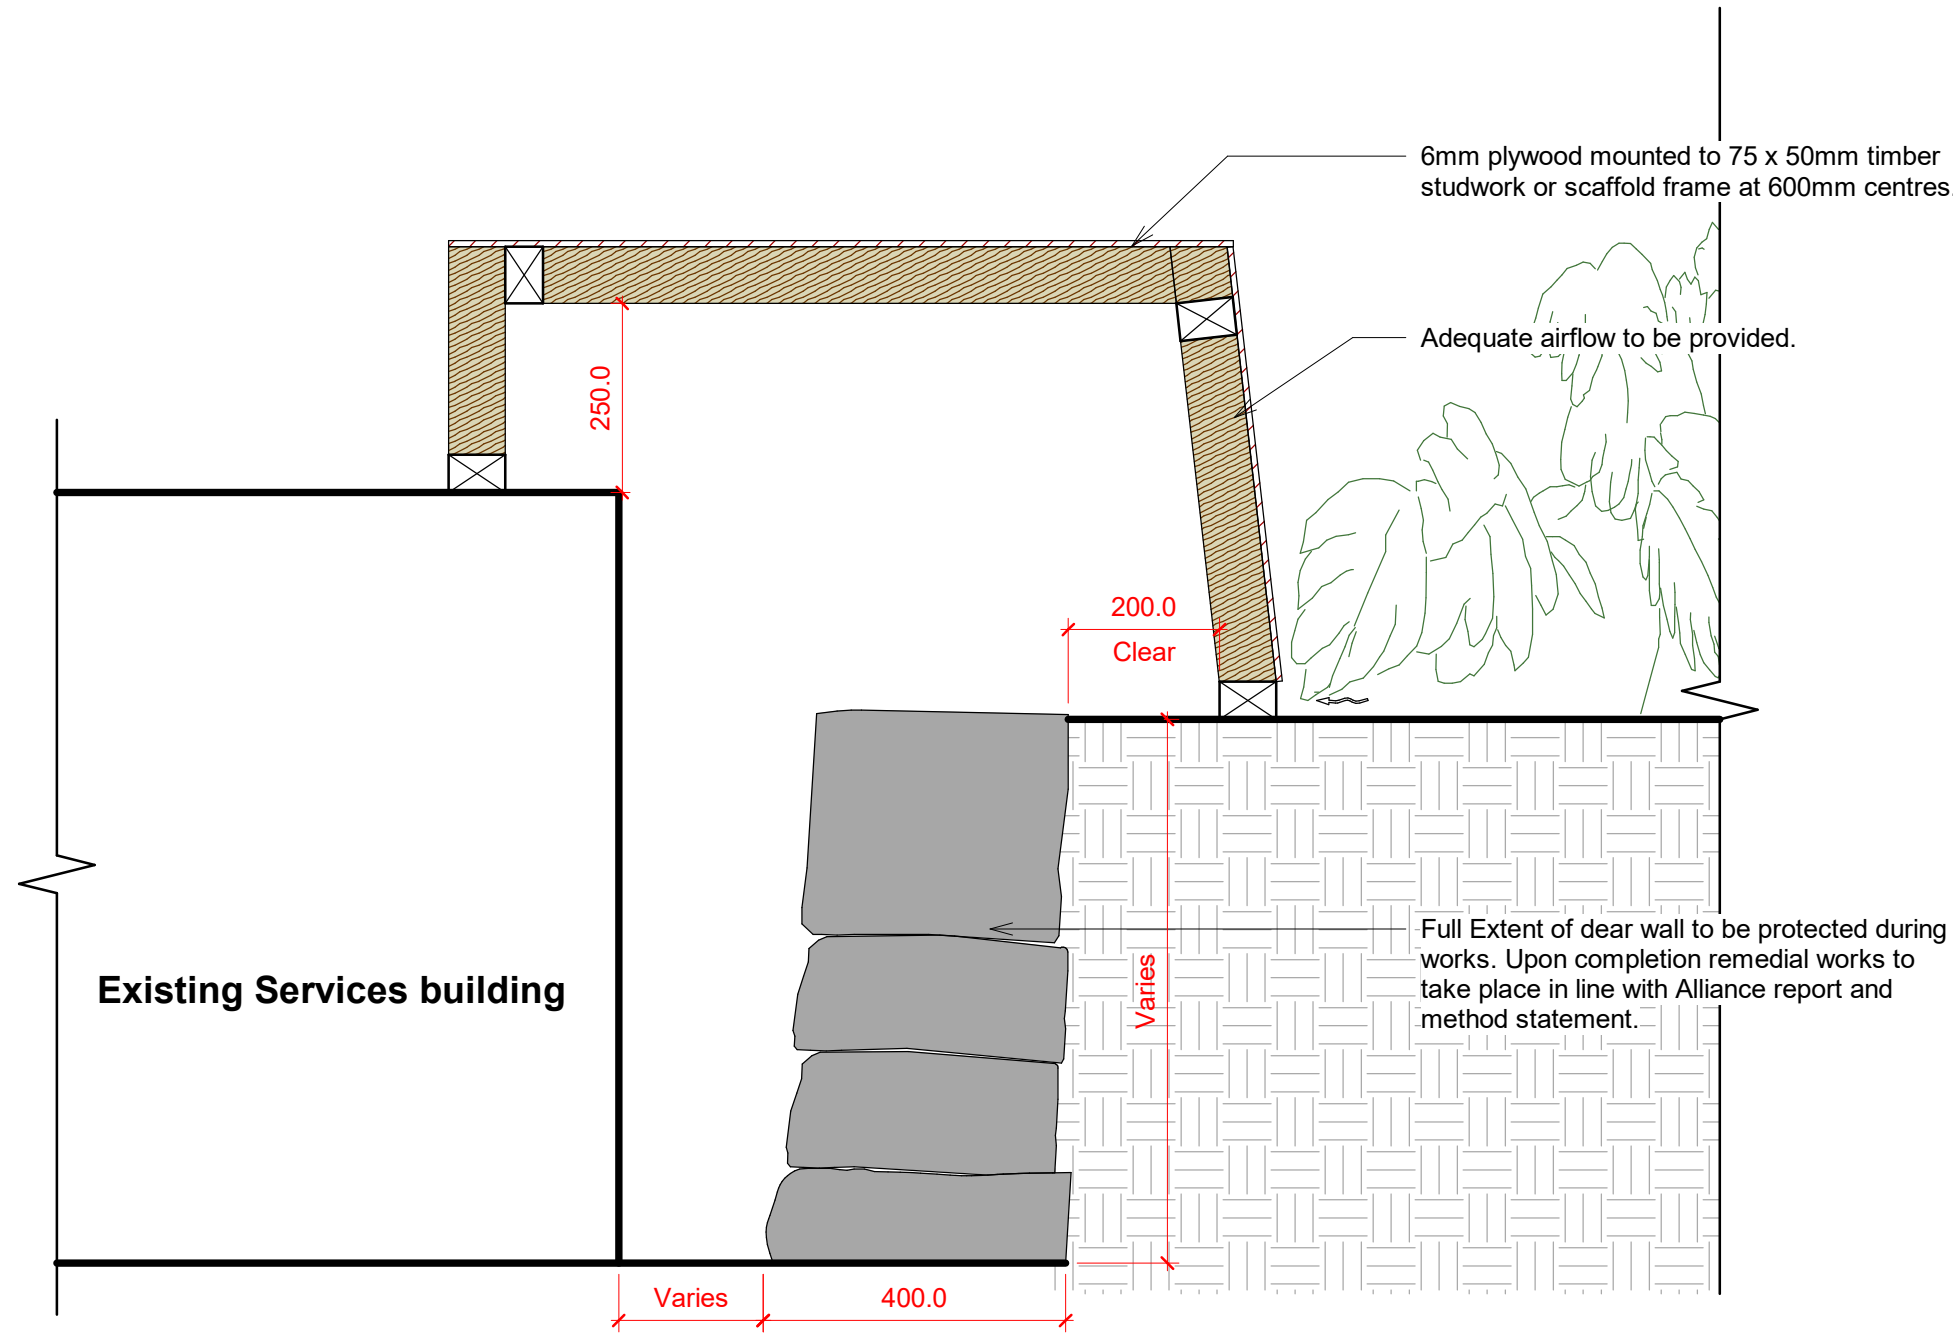
2 Deer Wall Protection Detail (Behind existing Services)  
1 : 10

ALL REPAIR WORKS TO BE CARRIED OUT BY A COMPETENT SPECIALIST CONTRACTOR.
