W02

| DRAWING No. | TITLE<br>CH COTTAGE W02 E/P | DRAWN by<br>Paul Statham | | |

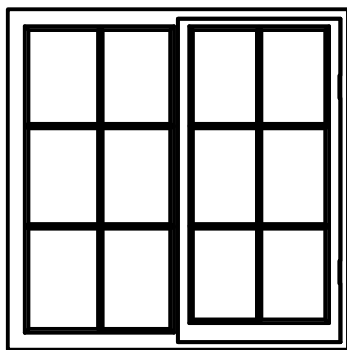
PROPOSED

ALL EXISTING TIMBER AND GLASS RETAINED WHERE POSSIBLE, SMALL SCARFED REPAIRS IN MATCHING REDWOOD MAY BE REQUIRED IN LOCALISED AREAS OF ROT. ANY DAMAGED OR C20 GLAZING TO BE REPLACED WITH ~2.5MM CYLINDER GLASS. ALL GLAZING SEALED WITH LINSEED OIL PUTTY. WINDOW HARDWARE RETAINED. REMOVAL OF C20 BRASS LOCKS. REPAINTED WITH HERITAGE PAINT IN OFF-WHITE TO MATCH ADJACENT MUSEUM COTTAGE.

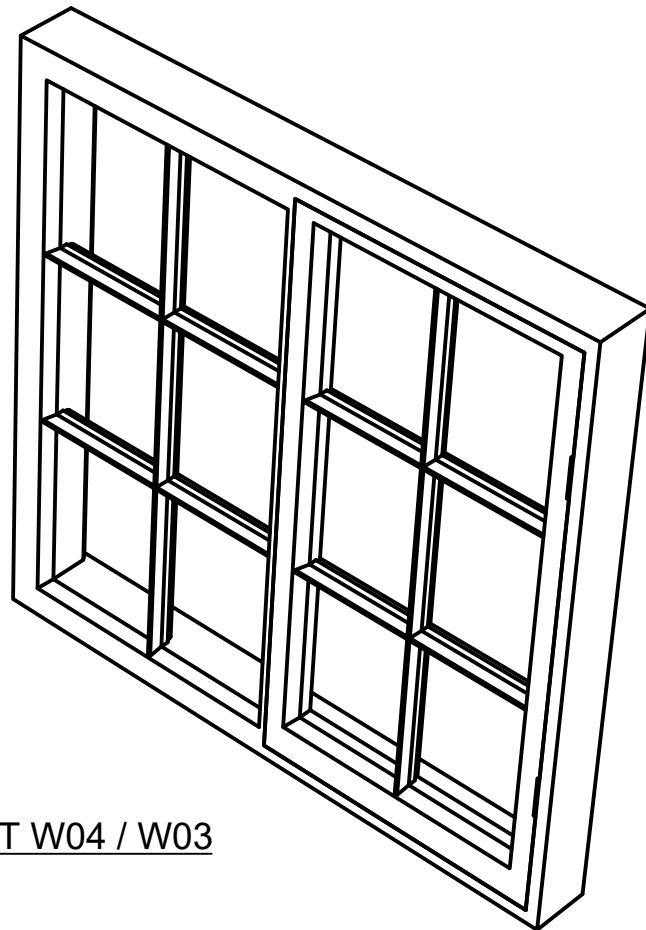
B (1:5)

MUNTIN PROFILE TO MATCH EXISTING AT W04 / W03

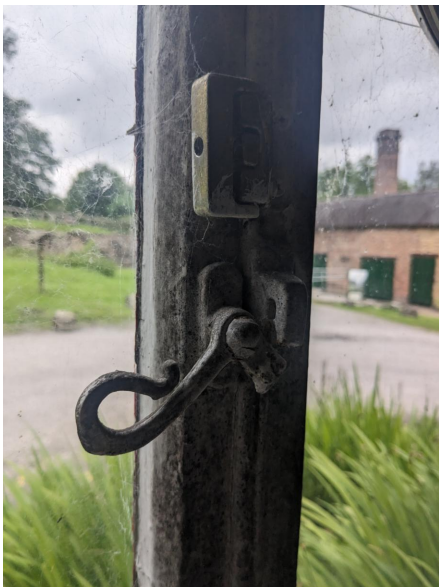
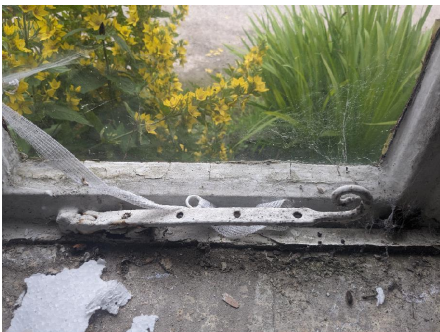
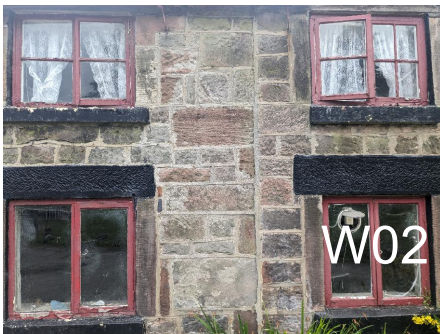
AS EXISTING

A-A (1:20)
