W04

| DRAWING No. | TITLE<br>CH COTTAGE W04 E/P | DRAWN by<br>Paul Statham | | |

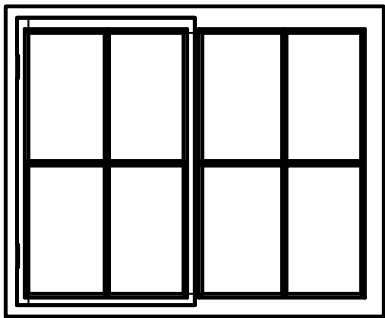
PROPOSED

ALL EXISTING TIMBER AND GLASS RETAINED WHERE POSSIBLE, SMALL SCARFED REPAIRS IN MATCHING REDWOOD MAY BE REQUIRED IN LOCALISED AREAS OF ROT. ANY DAMAGED OR C20 GLAZING TO BE REPLACED WITH ~2.5MM CYLINDER GLASS. ALL GLAZING SEALED WITH LINSEED OIL PUTTY. WINDOW HARDWARE RETAINED. REMOVAL OF C20 BRASS LOCKS. REPAINTED WITH HERITAGE PAINT IN OFF-WHITE TO MATCH ADJACENT MUSEUM COTTAGE.

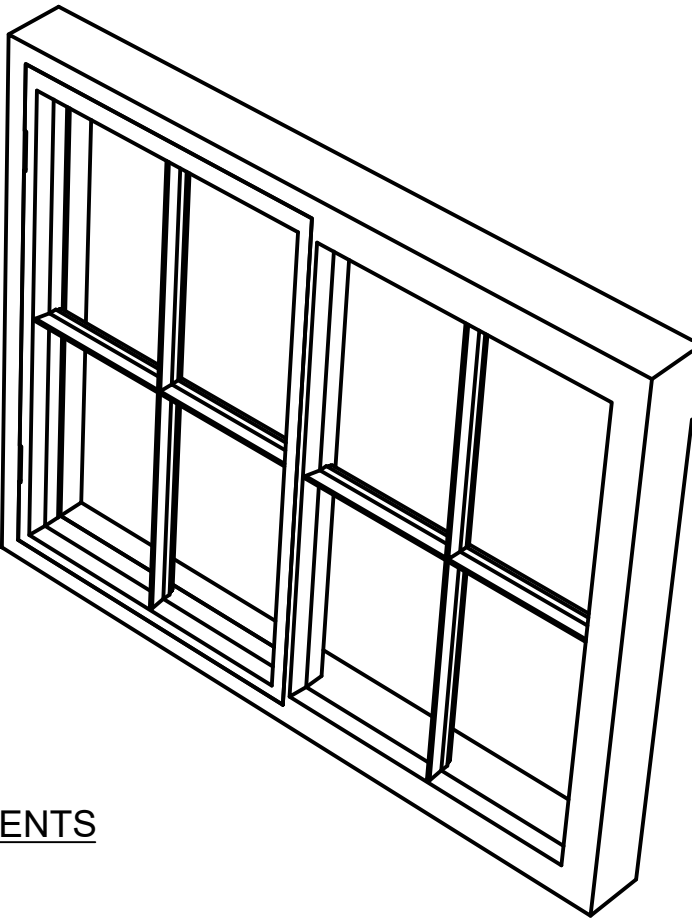
B (1:5)

MUNTIN PROFILE TO MATCH EXISTING ELEMENTS
