**SMD/2024/0398**

**Listed Building Consent for Alterations to the Farmhouse, Outbuilding and Garden at Cumberledge Farm**

**The Farmhouse at Farmstead, Cumberledge Farm, Huntley Road, Denford, Leek, Staffordshire, ST13 7JU**

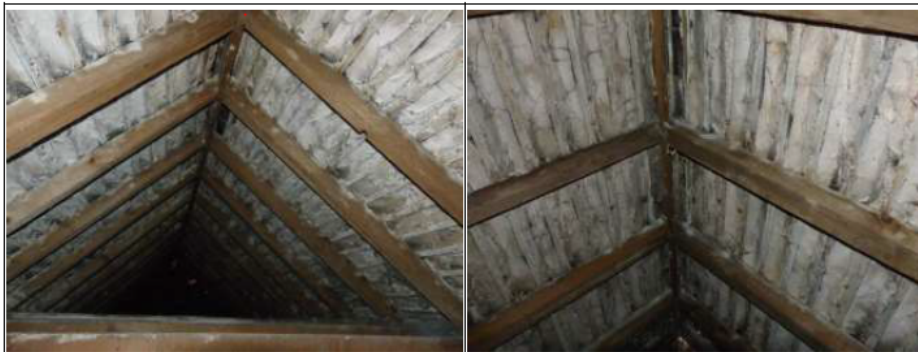
**Plate 2** – Extract from the Heritage Statement recording the presence of a loft void which is not mentioned/included in the Bat Report.

The roof void above the purlins is only visible through the loft access hatch. A ridge board and rafters are visible.

*Roof Structure – Ridge Beam, Rafters and Battens*

The bat report re-states that the farmhouse has a 'vaulted ceiling therefore no loft space', however this contradicts the Heritage Statement which identifies a loft void above the 'room to the north-east' (See Plate 2 below) which may align with the brown long-eared bat emergence location. It is assumed this area was not assessed for bat potential/usage (for example, by placing a static recorder within the loft to record bat echolocation calls).
