Donald Insall Associates  
Chartered Architects and Historic Building Consultants

The Heath House, Tean, Stoke-on-Trent

Brick Pergola  
Removals/Strip Out Plan & Elevations

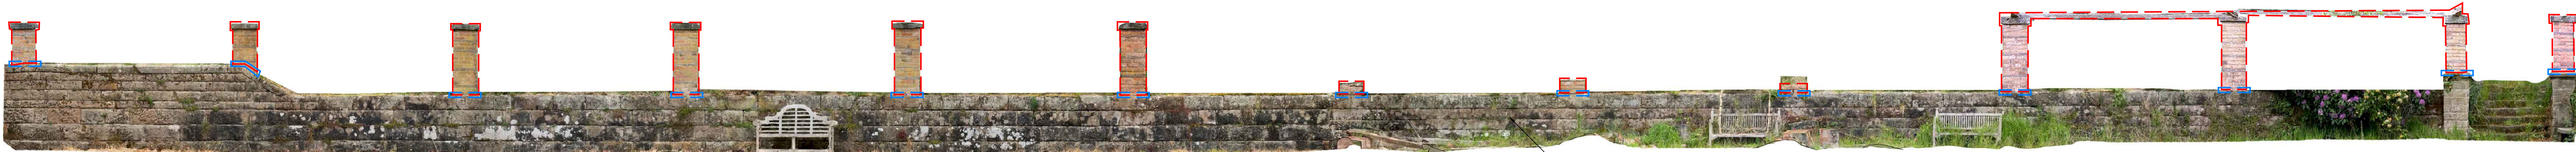
01 East Bank Elevation As Removal/Strip Out  
5020 1:50

- Careful removal / Strip out
- The existing brick piers will be carefully taken down to the stone coping of the underlying ashlar wall. All remnants of mortar associated with the brick piers will be removed from the upper face of the stone coping.
- Return of Existing Wall

Once the brick piers have been fully removed, a second phase of work will be carried out that will involve careful repair / conservation works to the historic ashlar walls, steps and seating. These works will form part of a separate subsequent application.

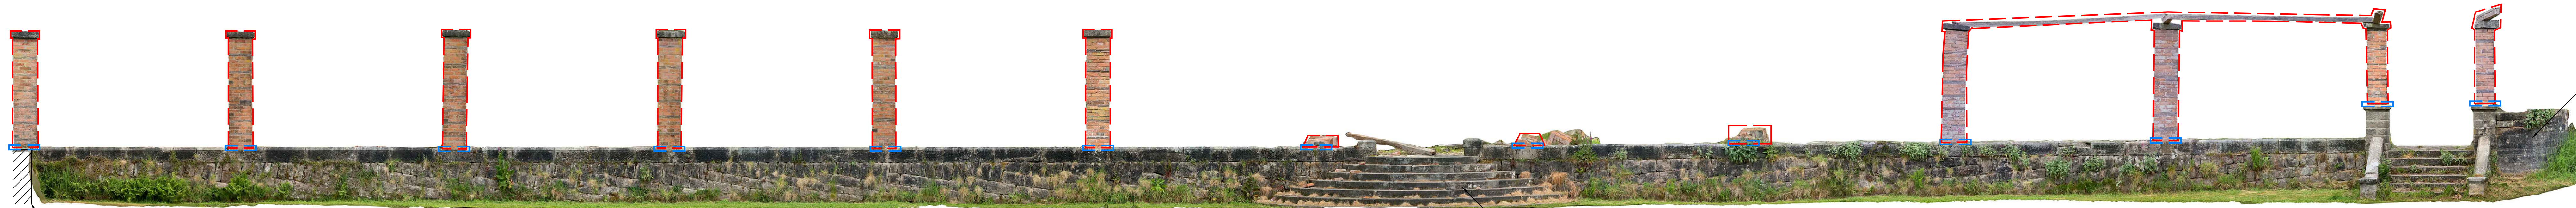
02 South Lawn Elevation As Removal/Strip Out  
5020 1:50

Existing stone seating to be retained

Once the brick piers have been fully removed, a second phase of work will be carried out that will involve careful repair / conservation works to the historic ashlar walls, steps and seating. These works will form part of a separate subsequent application.

Return of wall

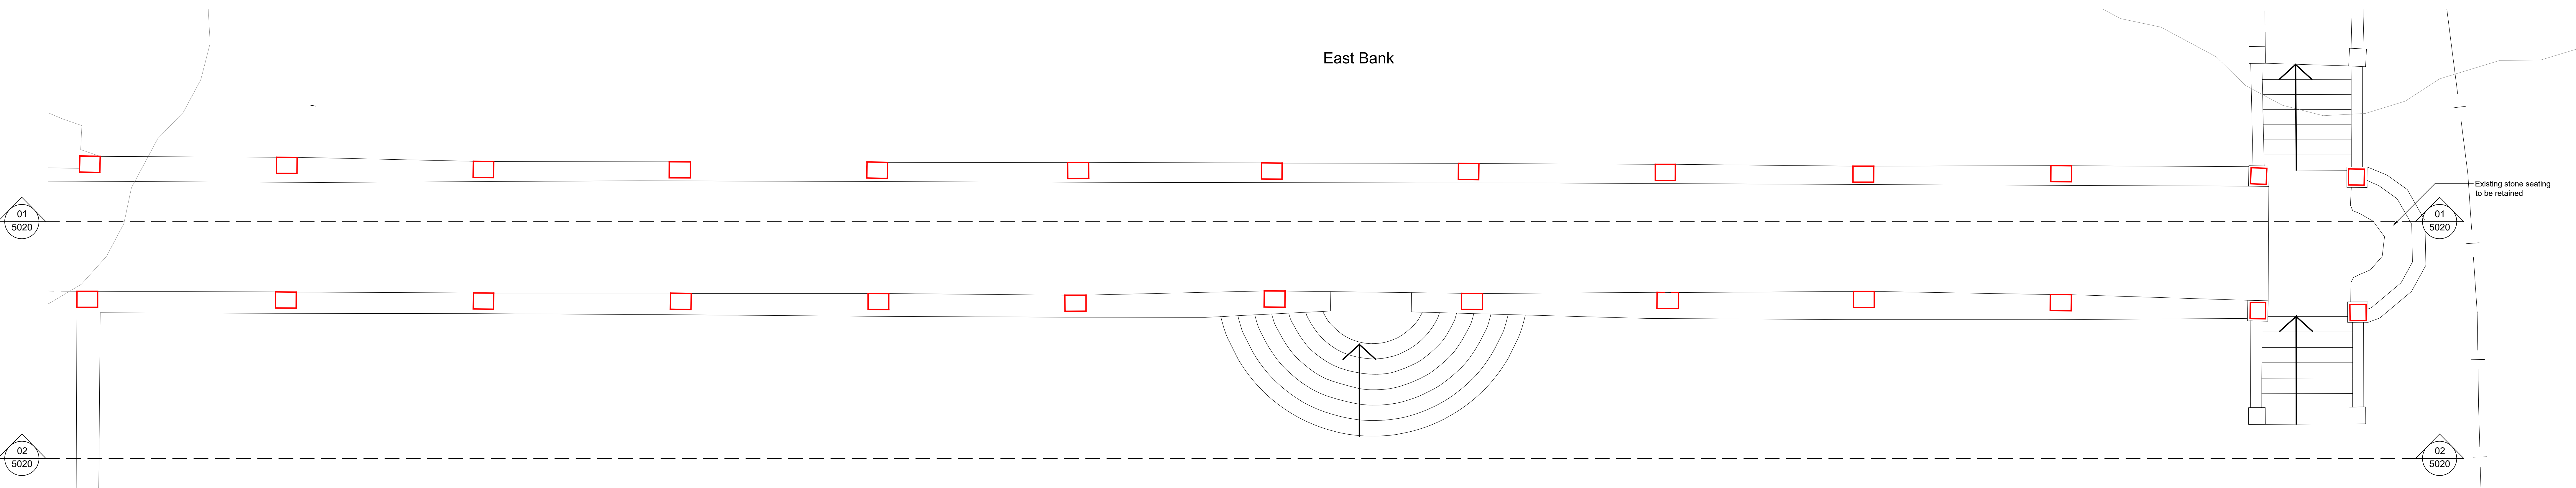
03 Plan As Removal/Strip Out  
5020 1:50

Existing stone seating to be retained
